Lincshore 2010 - 2015 Scoping Report

(July 2009)

The Lincolnshire Shoreline Management Plan (SMP) established a policy of ‘hold the existing defence line’ for the Lincshore coastline. As part of the Lincshore Coastal Defences Strategy (covering Donna Nook to Skegness) we are proposing to implement the SMP. To deliver the strategy, beach nourishment material will continue to be placed annually along the coastline between Mablethorpe and Ingoldmells. A performance review of the beach nourishment project has been undertaken, in preference to a full strategy review, which supports the Lincshore project, enabling a 0.5% annual probability of flooding (1 in 200 year return period) standard of protection along the frontage over a period of 100 years. Initial consultation was undertaken in April 2009 with statutory and non-statutory consultees. The aim of this Scoping Report is to present the findings of the scoping stage undertaken for the Lincshore Coastal Defences Strategy Project Appraisal 2010 – 2015 and to take them into account within the scoping process. This report also provides a record of consultation with relevant consultees.

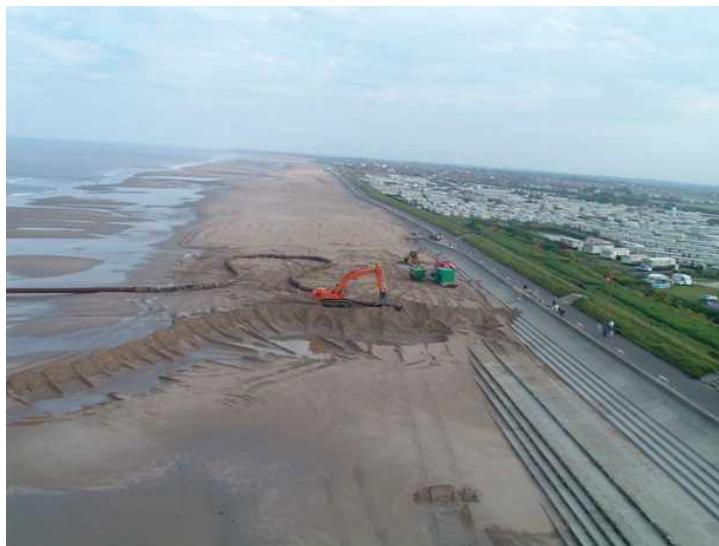
Photo 1 – Aerial view of the beach at Lincshore during nourishment

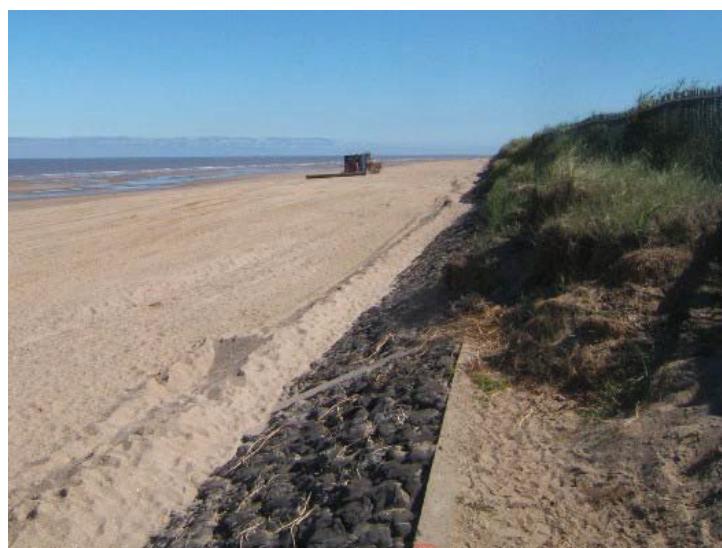
Photo 2 – Profiling of Beach

A Beach Profile Survey is undertaken by walking each profile section (refer to Section 2.1) using GPS elevation measuring equipment to record beach levels. The results of the survey identify deficiencies below the required design profile levels (i.e. the beach profiles which provide the required standard of protection) and inform the locations of annual nourishment for the subsequent year.

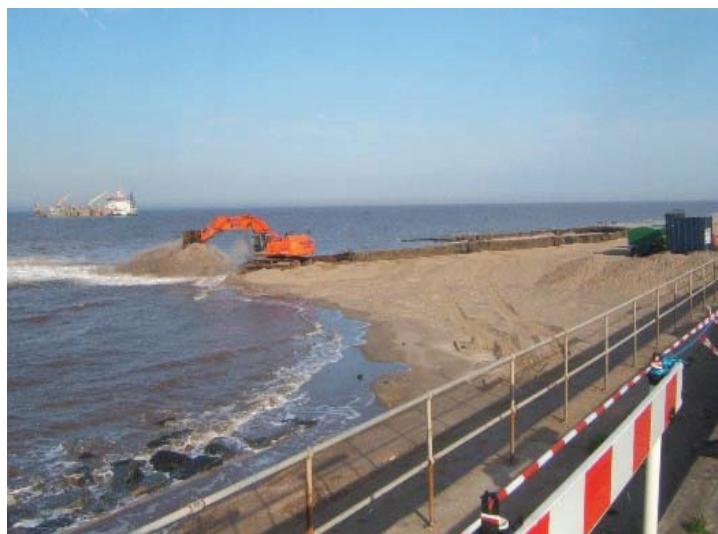
Based on previous works it is envisaged that the nourishment material will be sand, dredged from a licensed offshore dredging site. The dredger will couple to a pipeline which leads to the beach and pump the nourishment material onto the beach. The nourishment material will be shaped into the design profile using land-based plant.

Photo 3 – Onshore Pumping of Beach Nourishment

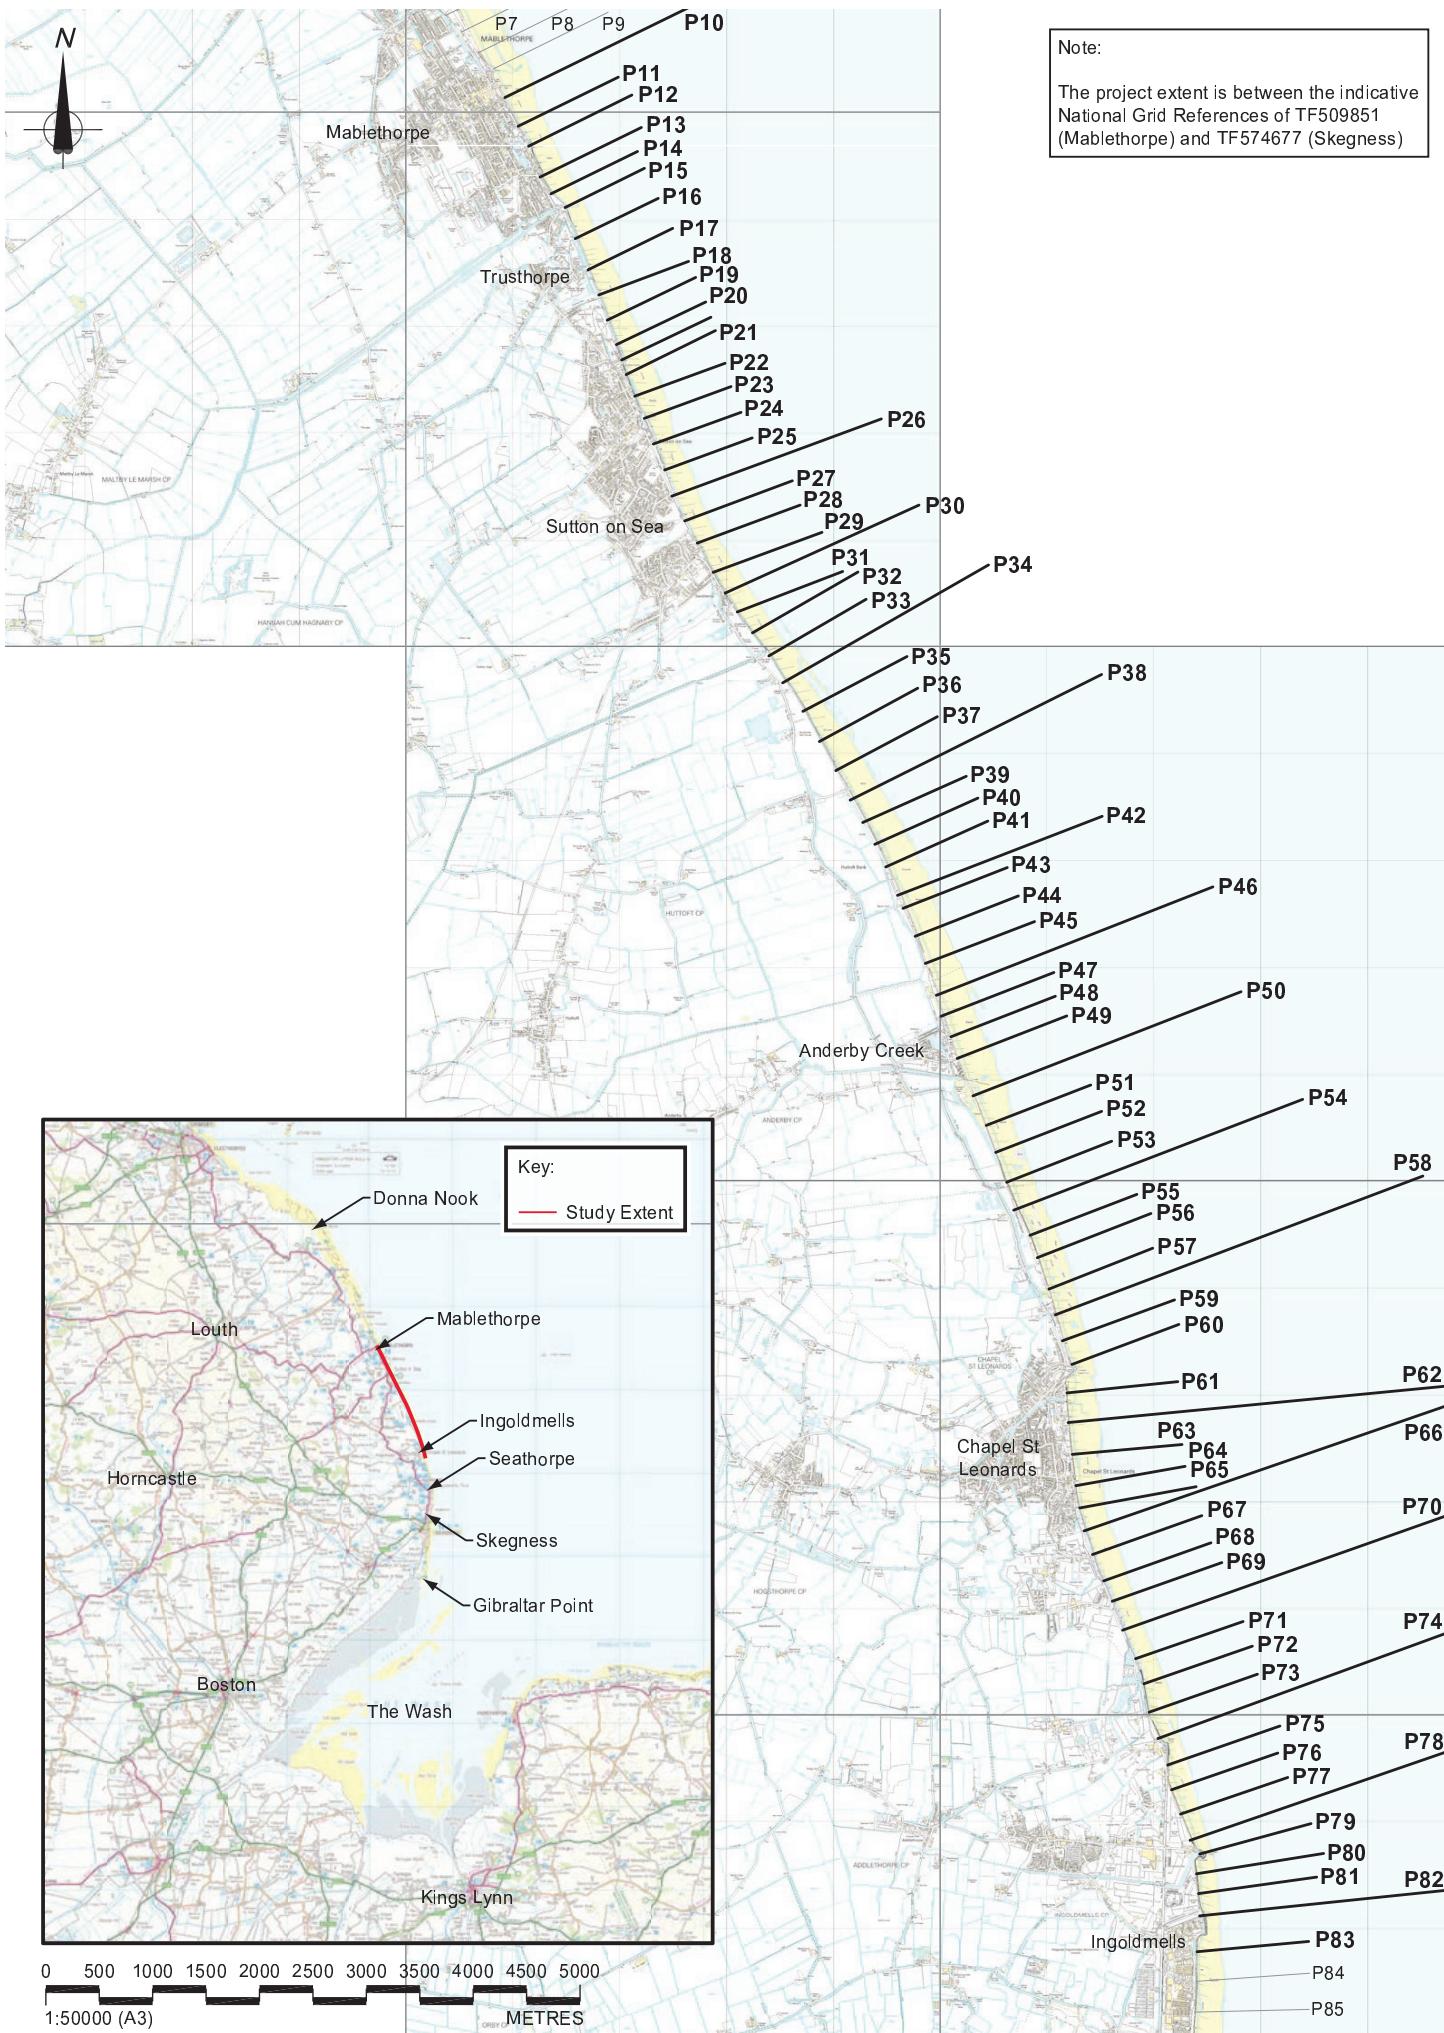
Lincshore Coastal Defence Strategy Project Appraisal 2010-2015 - Scoping Report
Site Location Plan and Profile Numbers - Figure 1

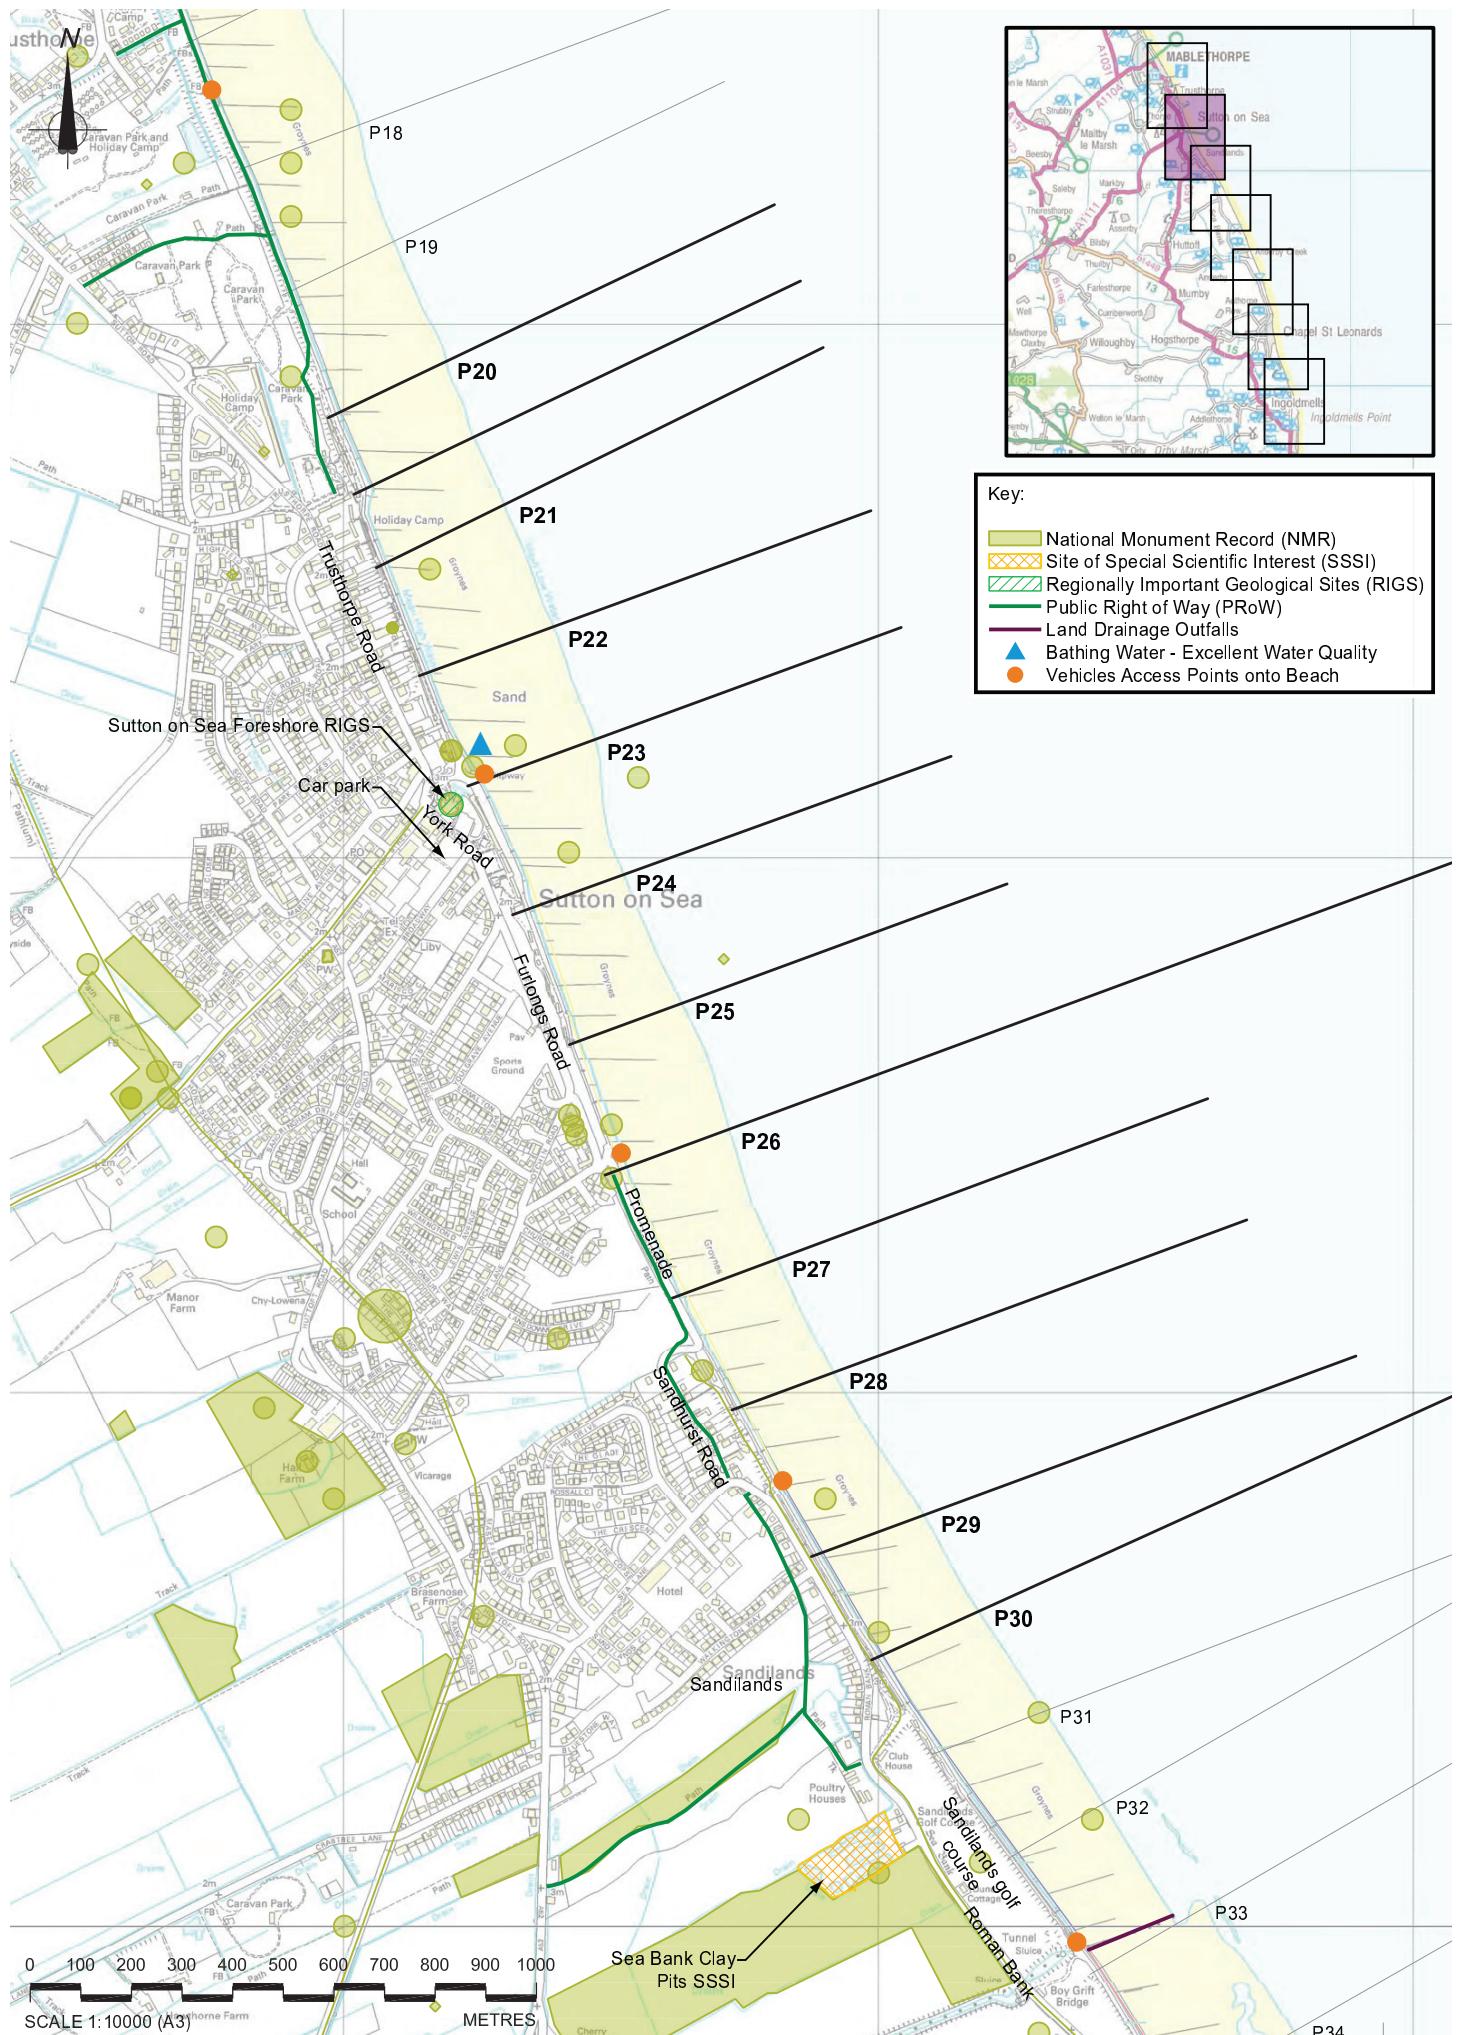
Lincshore Coastal Defence Strategy Project Appraisal 2010-2015 - Scoping Report
Environmental Constraints Plan - Profile Numbers 20-30 - Figure 3

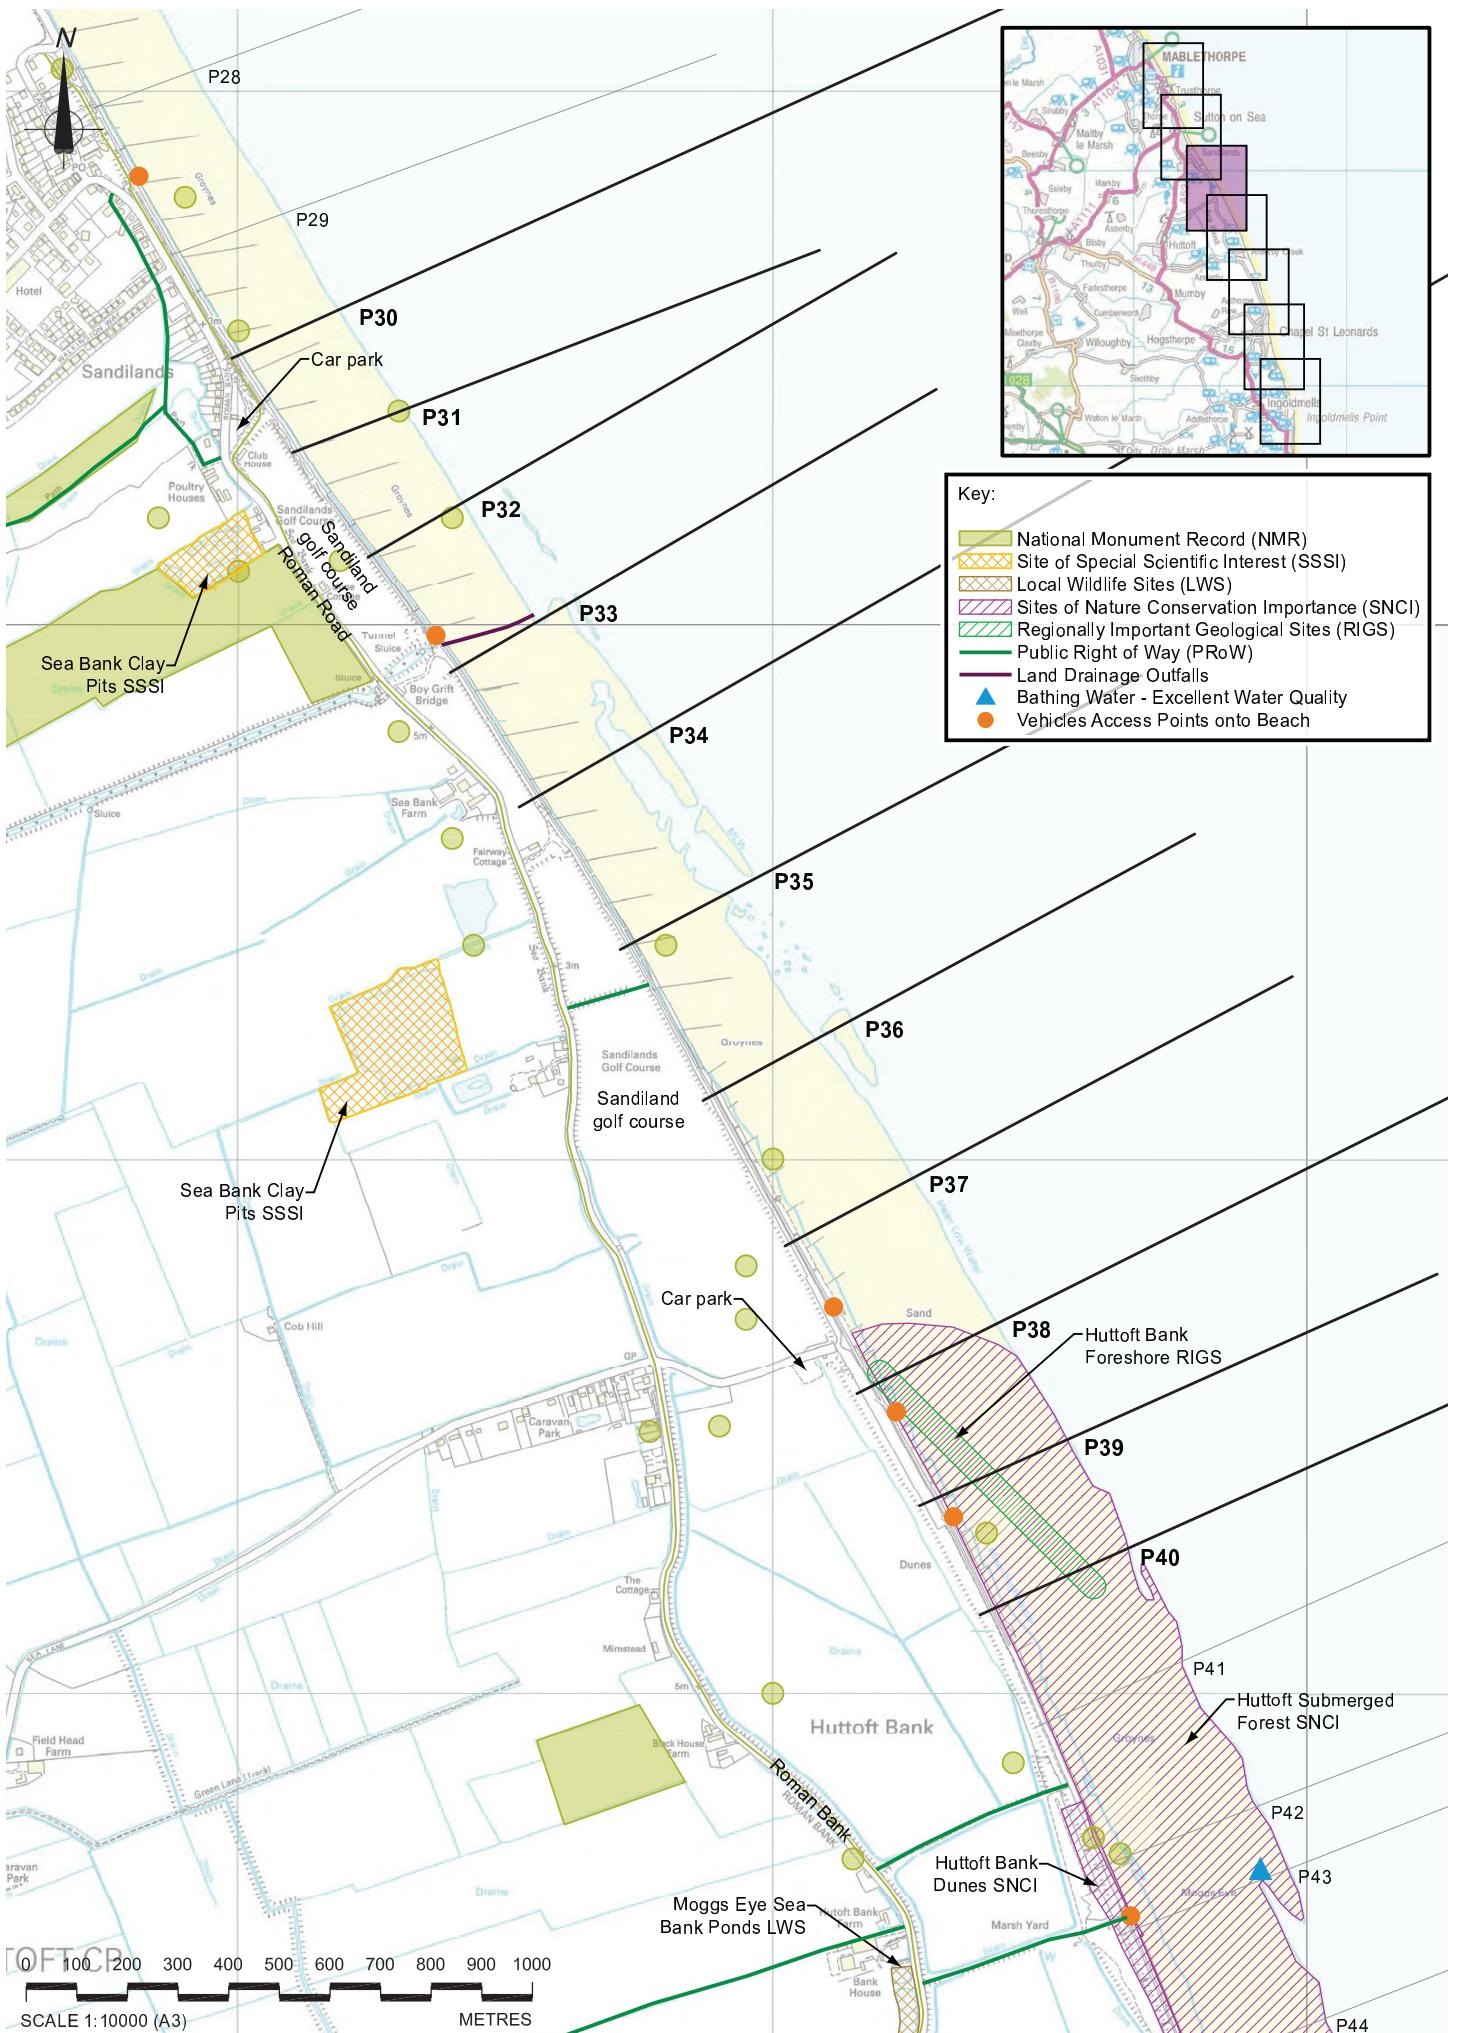
Lincshore Coastal Defence Strategy Project Appraisal 2010-2015 - Scoping Report
Environmental Constraints Plan - Profile Numbers 30-40 - Figure 4

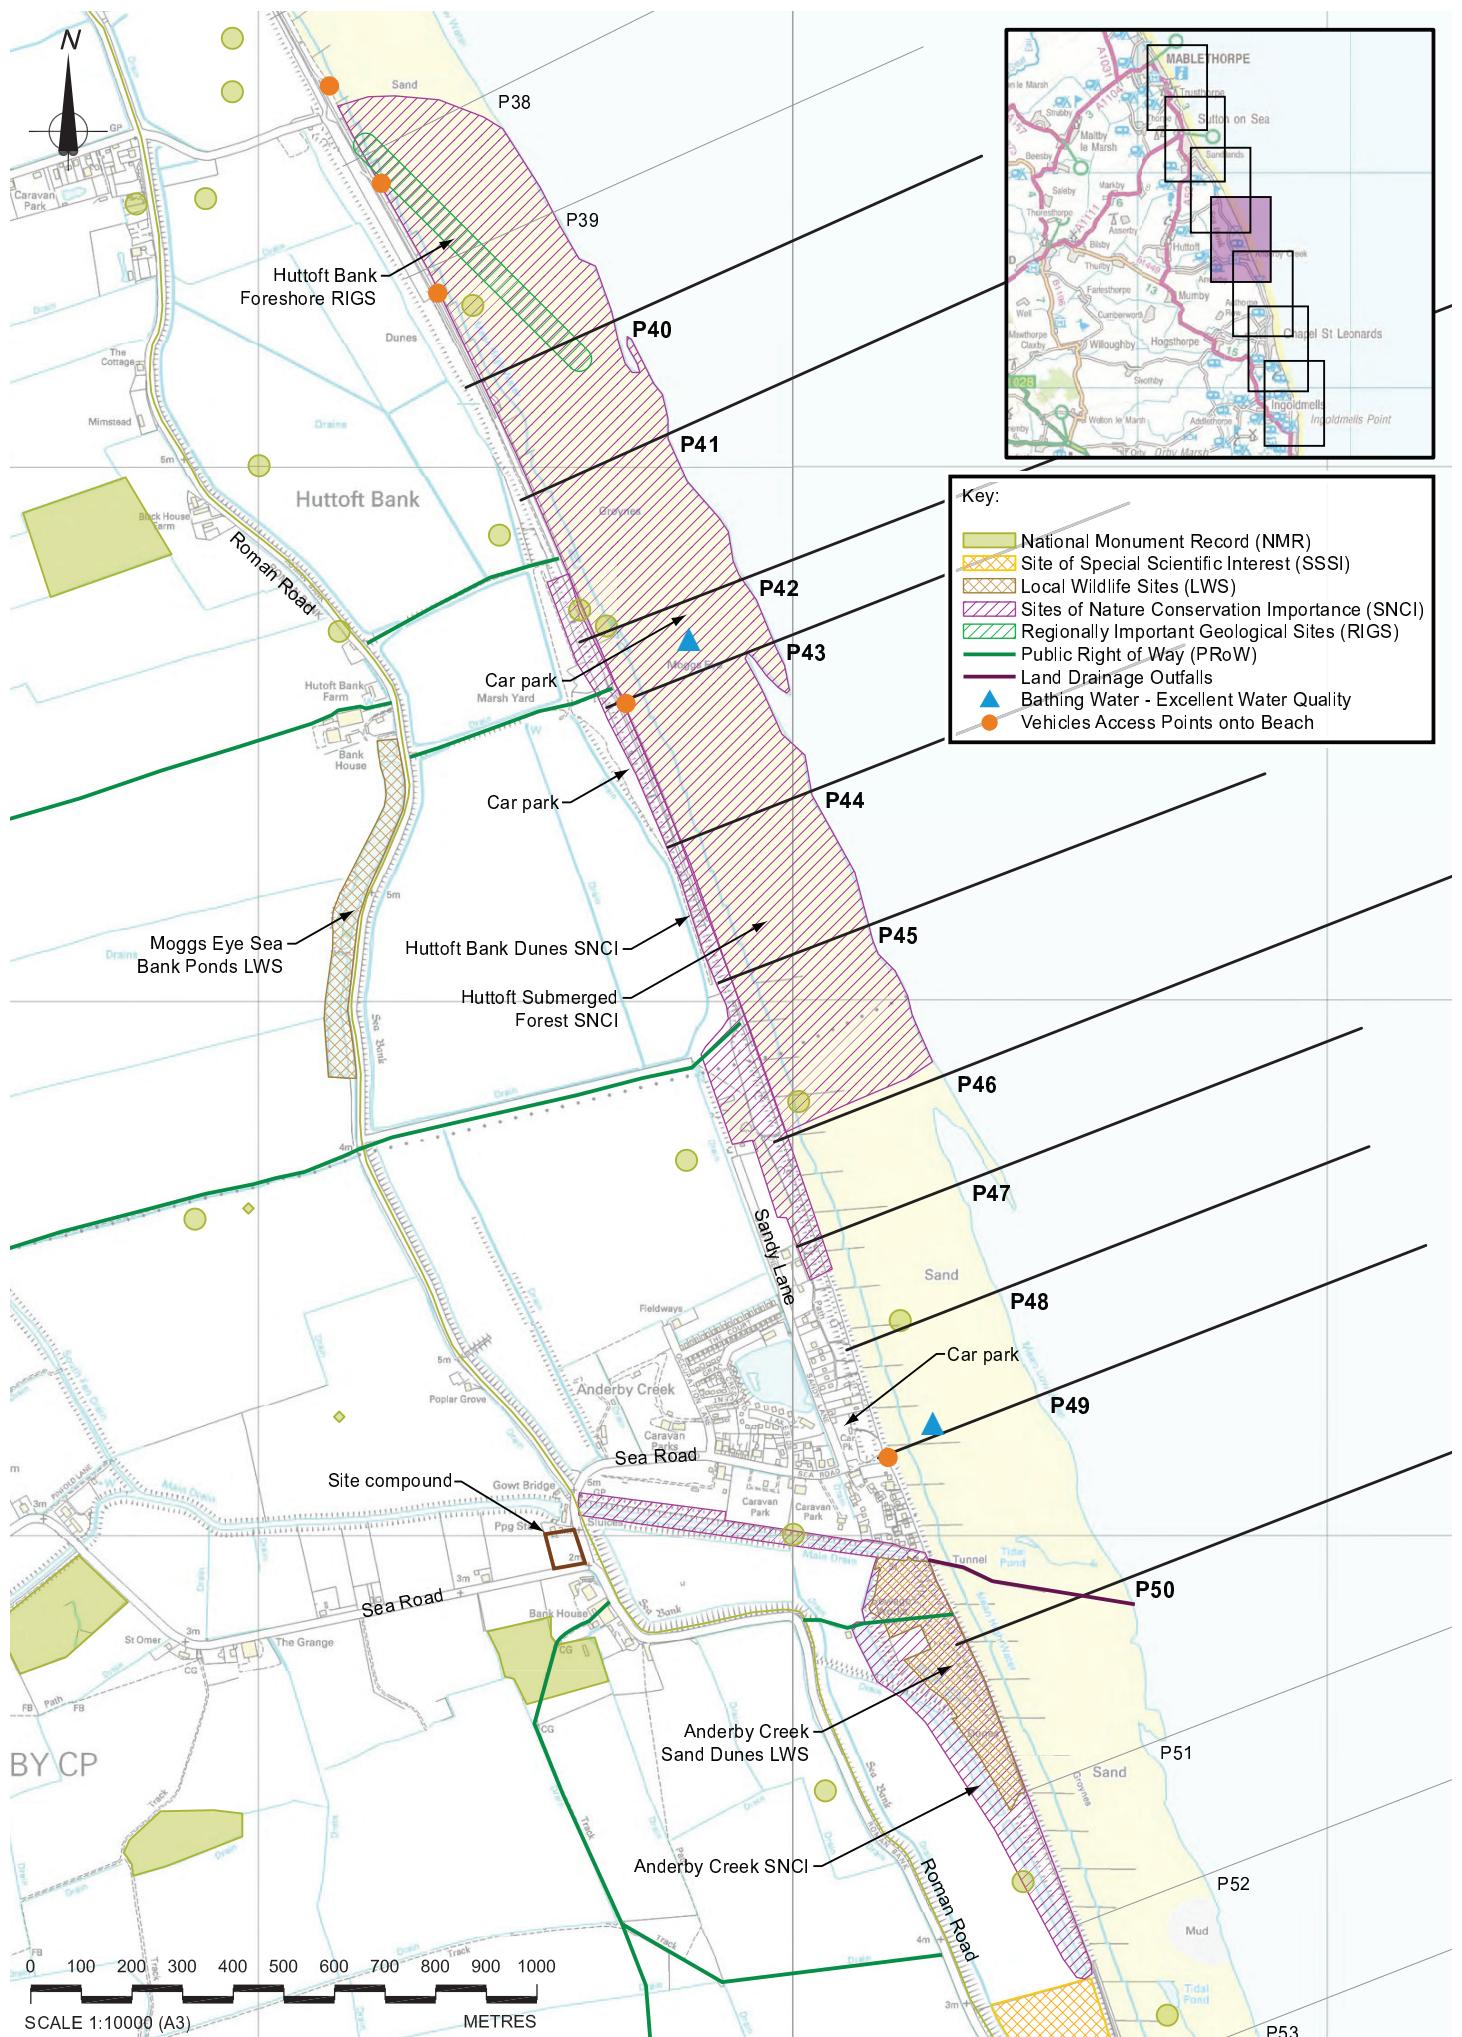
Lincshore Coastal Defence Strategy Project Appraisal 2010-2015 - Scoping Report
Environmental Constraints Plan - Profile Numbers 40-50 - Figure 5

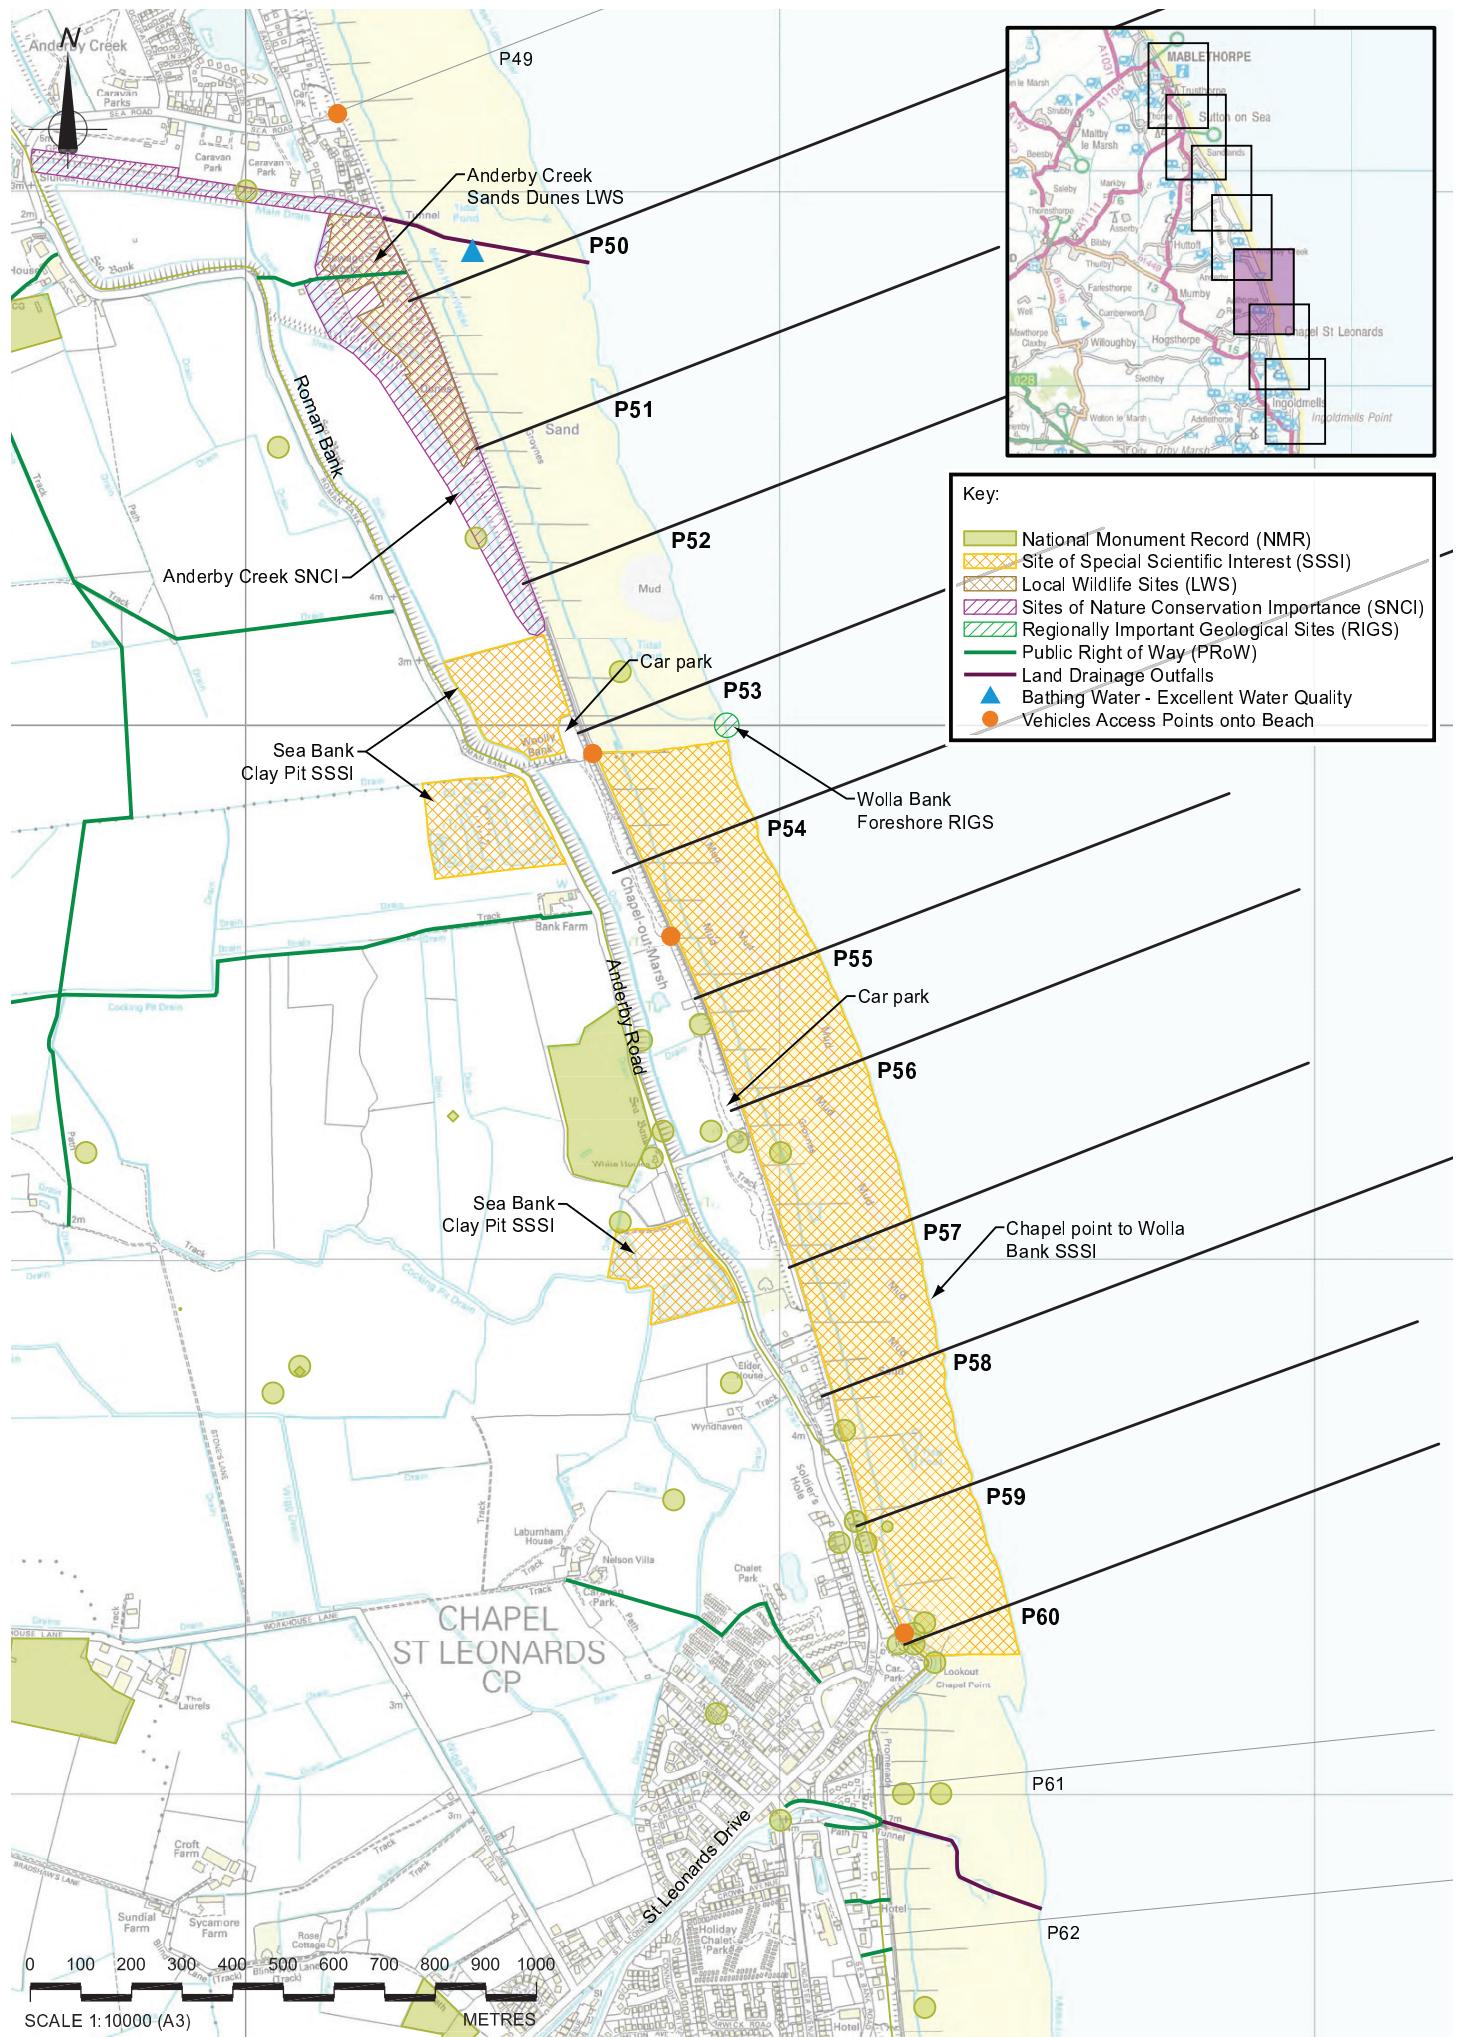
Lincshore Coastal Defence Strategy Project Appraisal 2010-2015 - Scoping Report
Environmental Constraints Plan - Profile Numbers 50-60 - Figure 6

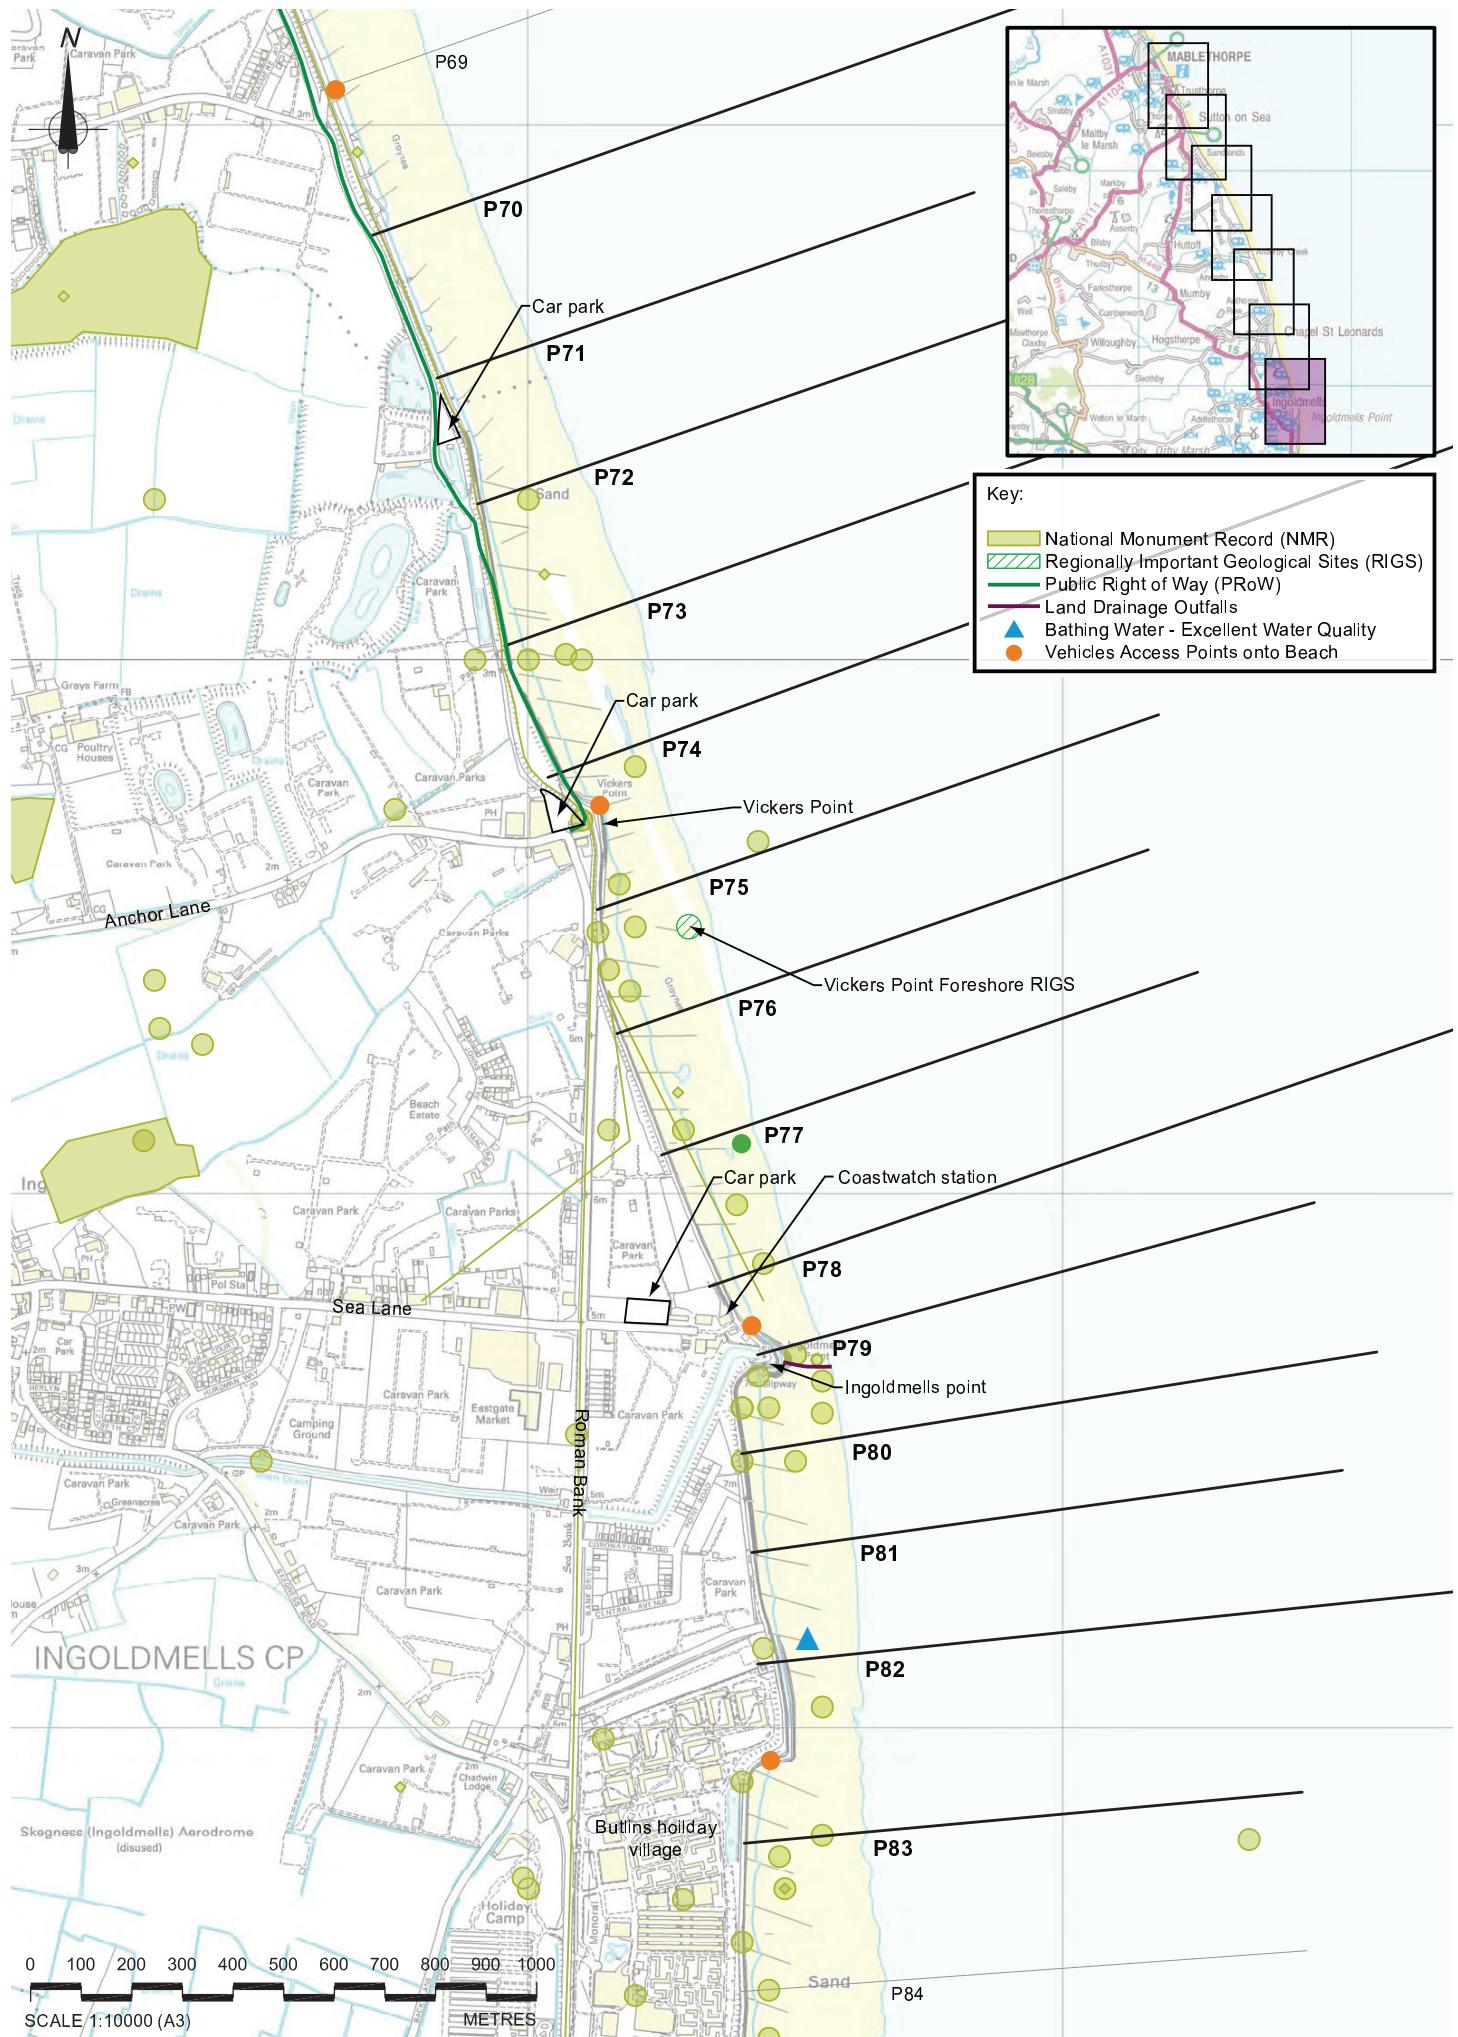
Lincshore Coastal Defence Strategy Project Appraisal 2010-2015 - Scoping Report
Profile Numbers 70-83 - Figure 8

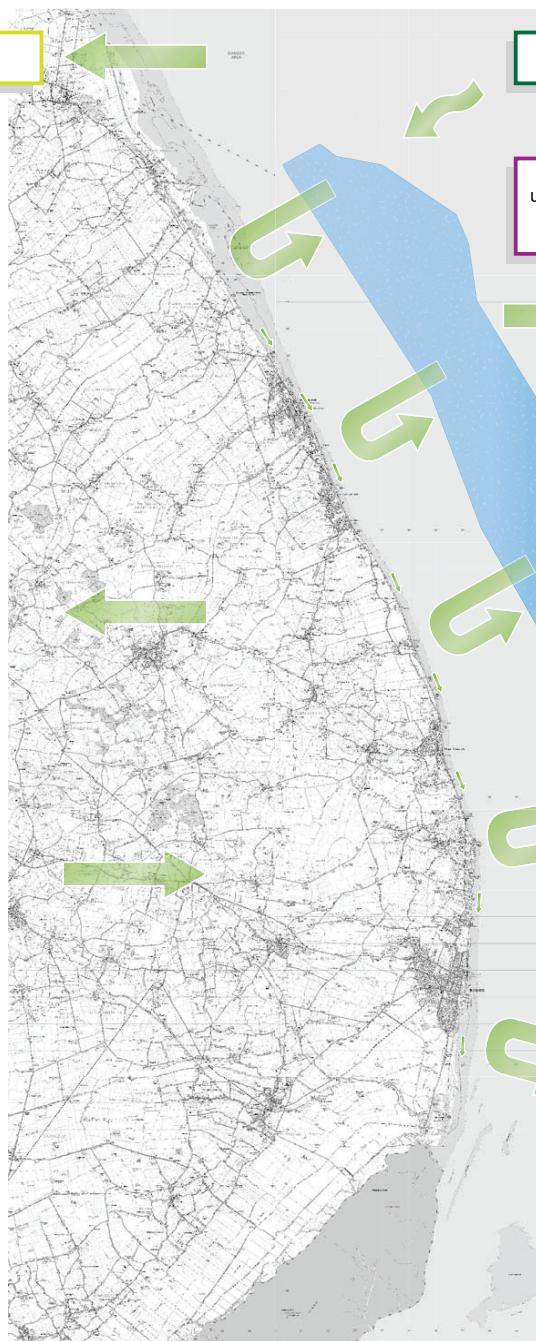
Store of beach material that has been drawn down under storm conditions to form a possible nearshore bar. Following cessation of the storm, the eroded material is returned to the beach

Permanent losses offshore

Potential sediment supply from offshore banks

Note: Processes highlighted in yellow represent sediment inputs to the system; those in red represent losses from it and blue stores within it. Green represents movement.

Key: The size of arrows does not indicate the rate or magnitude of sediment transport and are only used to indicate potential sediment transport pathways.

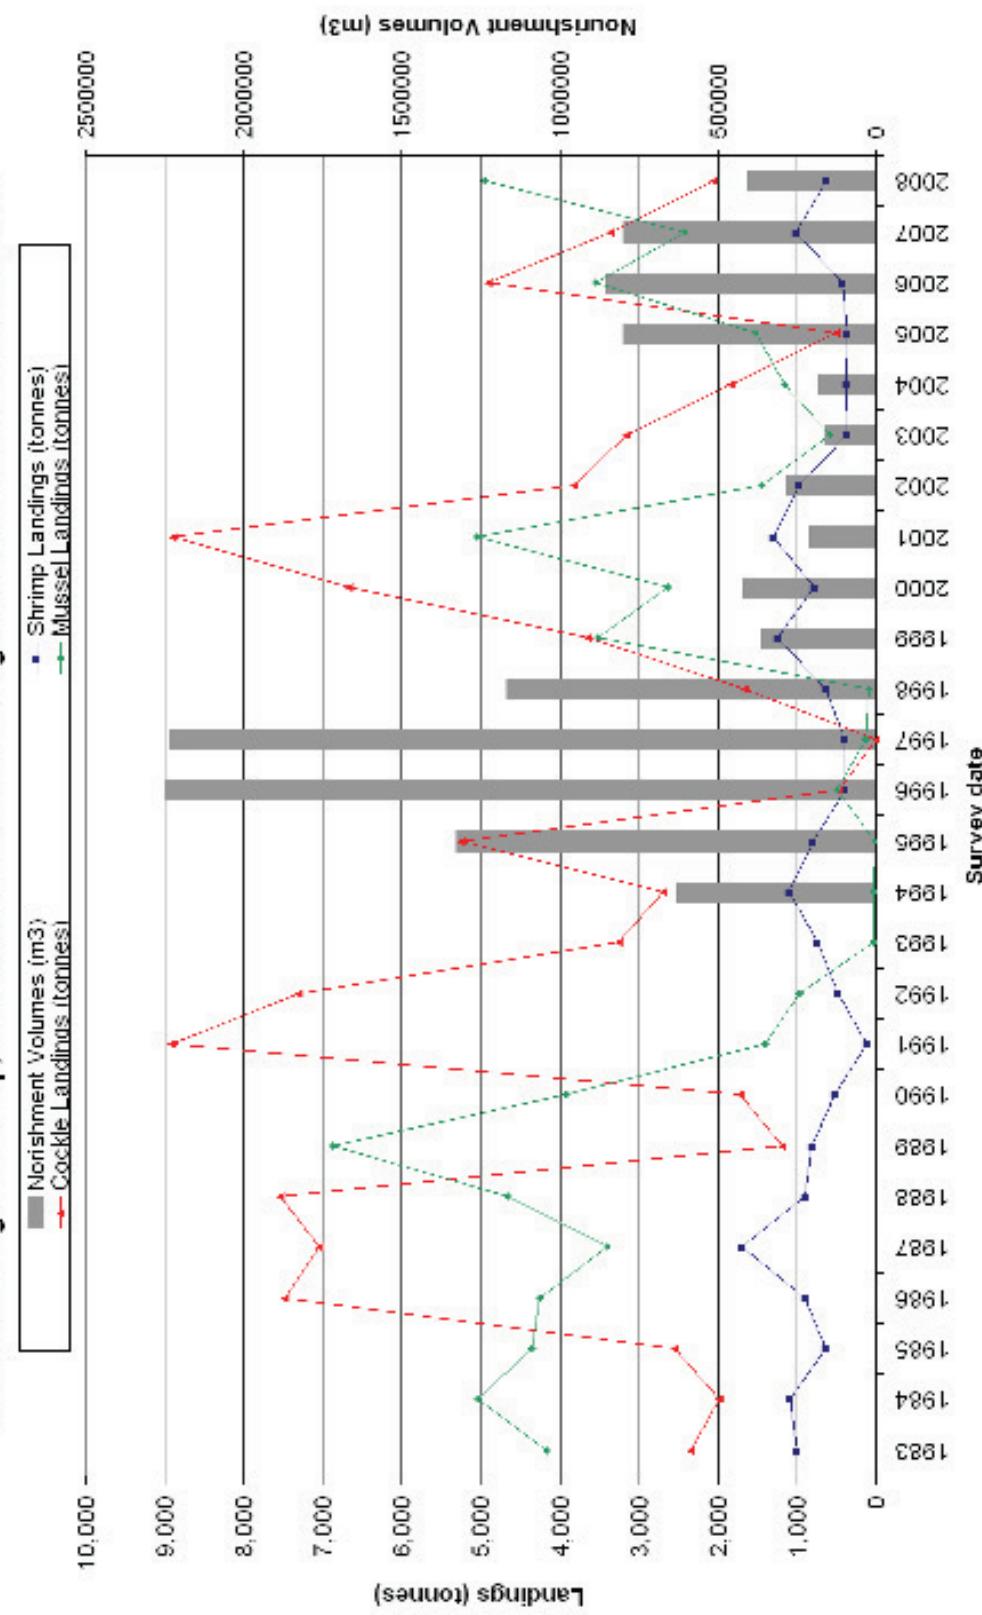
Table 13 - Graph showing the annual landings for the Wash of Shrimp, Mussel and Cockles shown against beach nourishment volumes, 1983-2008

Annual Landings of Shrimp, Mussel and Cockles shown against beach nourishment 1983-2008
