Lincshore 2010 - 2015 Scoping Report

(July 2009)

The Lincolnshire Shoreline Management Plan (SMP) established a policy of ‘hold the existing defence line’ for the Lincshore coastline. As part of the Lincshore Coastal Defences Strategy (covering Donna Nook to Skegness) we are proposing to implement the SMP. To deliver the strategy, beach nourishment material will continue to be placed annually along the coastline between Mablethorpe and Ingoldmells. A performance review of the beach nourishment project has been undertaken, in preference to a full strategy review, which supports the Lincshore project, enabling a 0.5% annual probability of flooding (1 in 200 year return period) standard of protection along the frontage over a period of 100 years. Initial consultation was undertaken in April 2009 with statutory and non-statutory consultees. The aim of this Scoping Report is to present the findings of the scoping stage undertaken for the Lincshore Coastal Defences Strategy Project Appraisal 2010 – 2015 and to take them into account within the scoping process. This report also provides a record of consultation with relevant consultees.

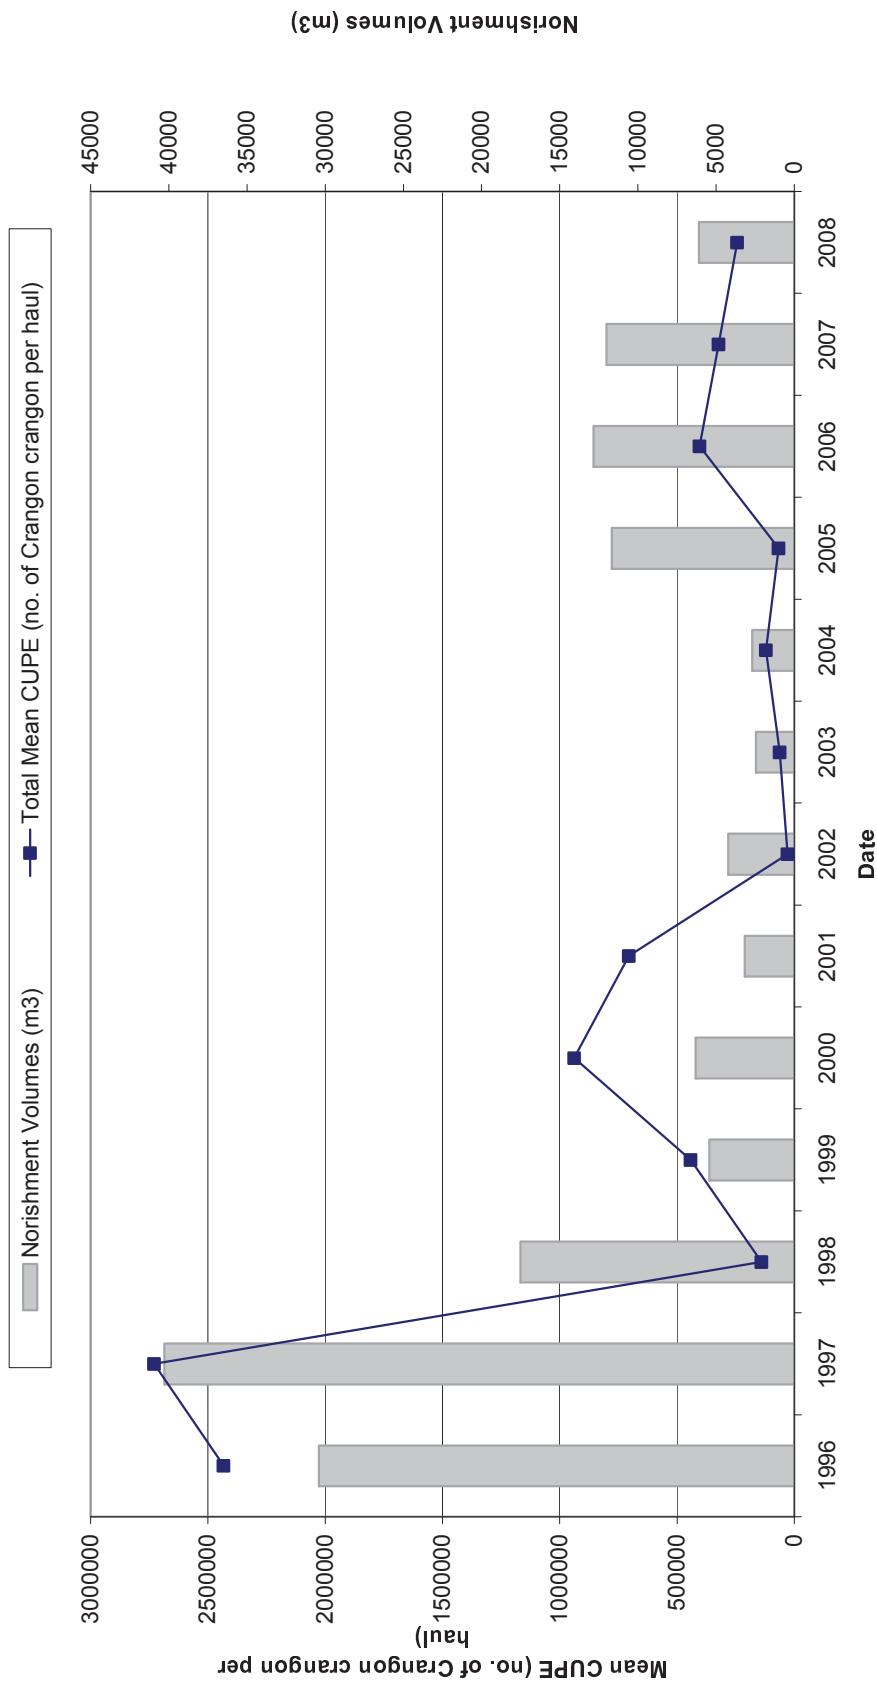
Table 15 – Environmental Monitoring: Total Volumes of shrimp hauls shown against beach nourishment 1996-2008

**Environmental Monitoring: Total volumes of Shrimp populations shown against beach nourishment
1996-2008**
