ALFORD CONSERVATION AREA APPRAISAL

July 2008

PART A: ALFORD CONSERVATION AREA APPRAISAL

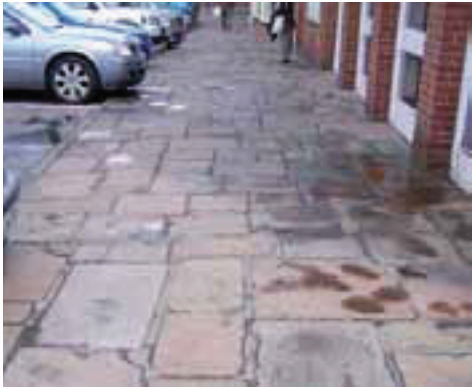
York stone paving, South Market Place

7.7.4 The THI enhancement scheme in the northern Market Place has reinstated York Stone paving and created an attractive public open space with seating and street furniture which contributes greatly to the Market Place.

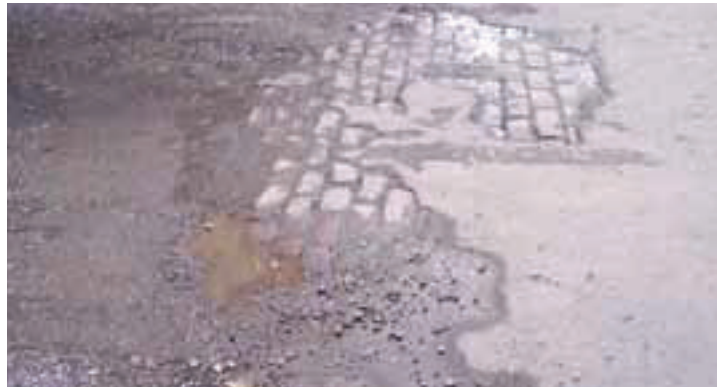
Exposed historic stone cobbles

7.7.3 Today there is a mix of traditional and non-traditional surfacing in Alford. The Market Place enhancement scheme has reintroduced cobbles and York stone paving in this area. On West Street at the entrance into the car park of the White Horse Hotel the asphalt is being worn away and historic stone cobbles are visible. Otherwise the conservation area is mainly covered with modern surfacing materials including concrete slabs and pavers or tarmac.

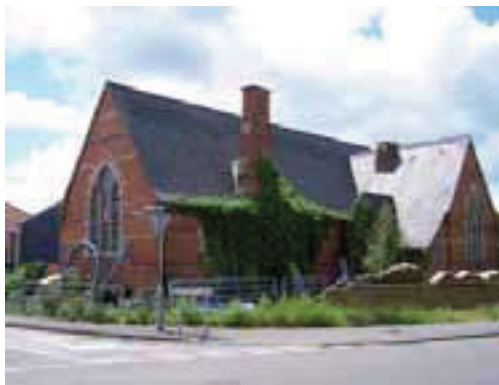
Derelict school building fronting West Street

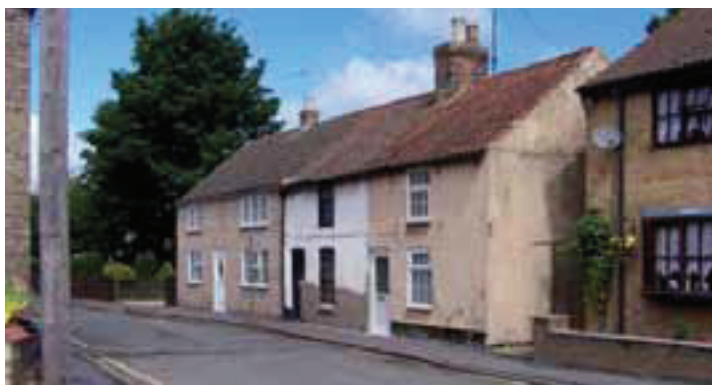
Replacement of windows and doors with uPVC,
Caroline Street

9.1.1 Throughout Alford, buildings have suffered from the removal/ alteration/ replacement of traditional features and materials. Works such as the replacement of windows and doors with uPVC or the re-roofing of properties with non traditional materials such as concrete interlocking tiles seriously erodes the historic and aesthetic value of the town. However, such works do not require planning permission on non listed domestic properties.

9.1.3 A number of buildings in Alford would benefit from the restoration of features which would have an enormously beneficial impact on the town's streetscape. As well as the large number of plastic replacement windows and doors in the town in some cases original window openings have also been altered. Encouragement to restore original windows, doors and openings would considerably enhance a number of streets. This is a particular problem on West Street, Caroline Street and to some extent Hamilton Road. A number of properties have had corbelled doorways blocked up, and the reinstatement of this feature or its introduction in new developments would help to promote local distinctiveness in Alford.

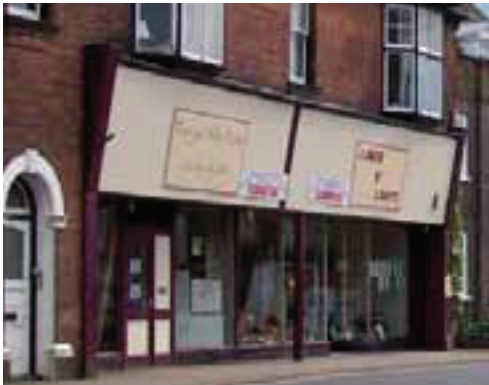
9.4.1 A number of shopfronts of poor quality or with inappropriate modern replacements are interspersed amongst some good traditional shopfronts predominantly along the High Street and West Street. These poor quality shopfronts detract from the overall

Poor quality shop fronts along West Street

character and appearance of the conservation area especially from the traditional buildings and streetscape that they are seen within. The appropriate repair of traditional shopfronts or replacement of unsympathetic shopfronts should be encouraged.
