# HORNCastle CONSERVATION AREA APPRAISAL

August 2008

# PART A: HORNCASTLE CONSERVATION AREA APPRAISAL

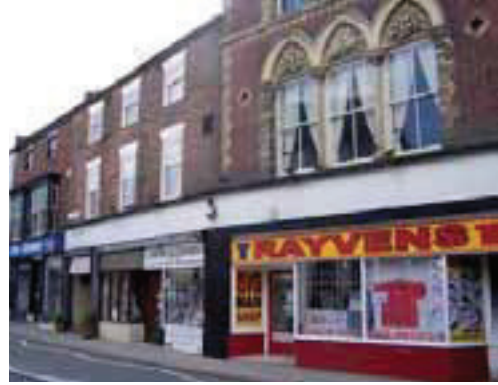
Poor quality shopfronts along Bridge Street

9.2.1 Horncastle has a good selection of late C18 to mid C19 shopfronts, and in particular those with 'Regency bow-windows', surviving today which are attractive and often listed. However, there are fewer good examples after this date, with most having been replaced or remodeled in the second half of the C20. Unfortunately these, predominantly 1960s and 70s shopfronts are of poor quality and do not respect the traditional proportions of the properties within which they sit. Restoring/reinstating traditional shopfronts would significantly enhance the appearance of the conservation area, hopefully attracting more visitors in the process.

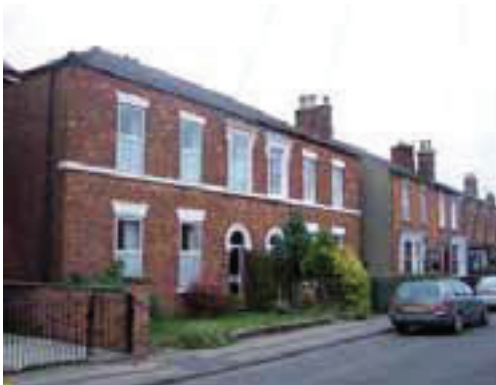
Contrast between traditional windows and poor modern replacements

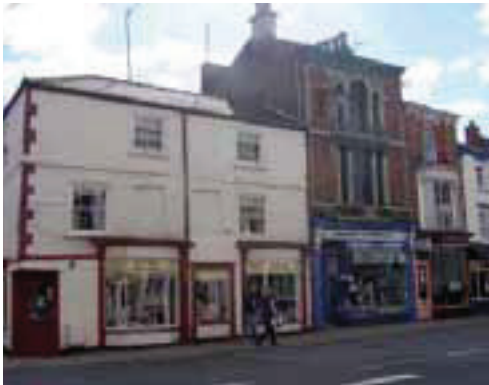
Good traditional shopfronts

11.1.1 Where traditional shopfronts and signage, or elements of them, survive, they should be retained and used as the basis for the restoration of the original frontage or incorporated into an appropriate new shopfront design. Removal of original features will only be permitted if they are beyond repair or are incapable of being successfully incorporated into a new shopfront.

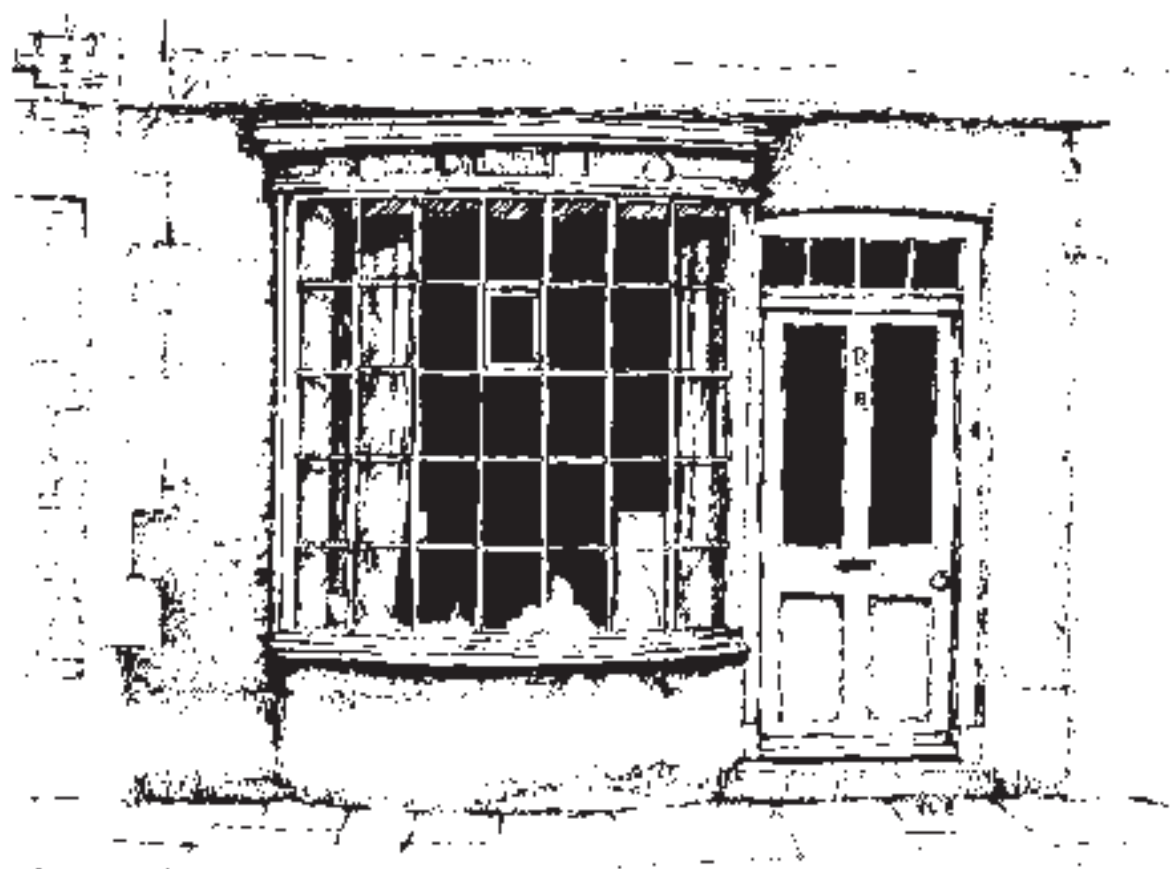
Fig. 10. Bow window, 13 West Street, Newcastle

With bow windows, the cornice is generally delicate and slim with a reduced projection. This avoided the reduction of the shop front's overall width by around 2 feet which would have been necessary if the cornice had been returned in the conventional fashion. Thus the neo-classical Adam style, with its miniaturised cornice and pilasters, was a favourite as it permitted liberties to be taken with the proportions of the architectural orders. The bow window at 13 West Street is a good local demonstration of the principle of such minimalist Adam-style detailing.

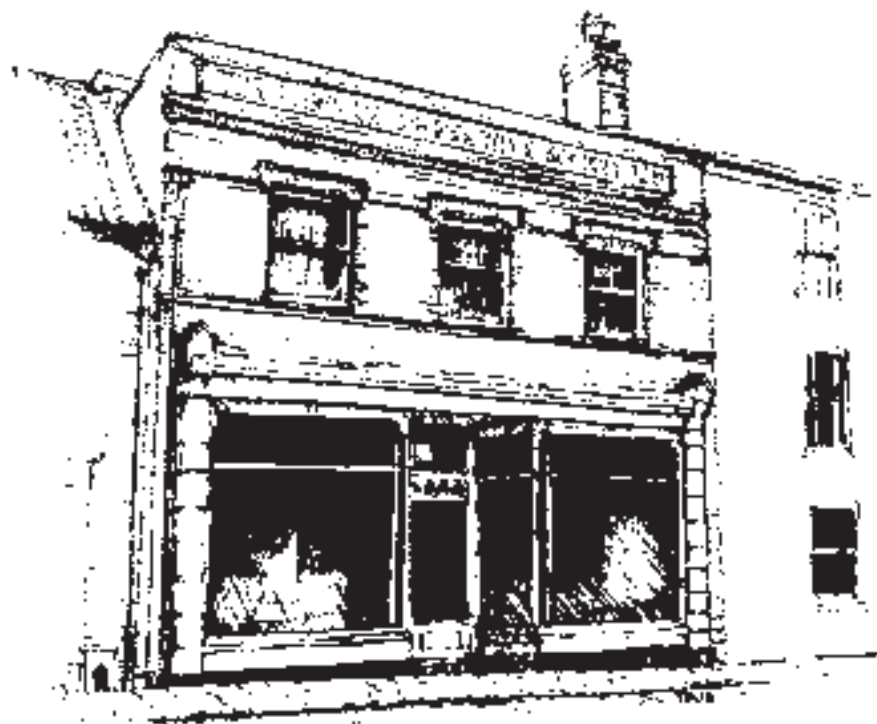
22 North Street, Horncastle, 1870s

The advent of the so now plate glass windows introduced a different scale to the design of shop fronts, with the stall-riser at the base of the window virtually disappearing, and the front being carried much higher up, thereby increasing the natural internal light. Rural Horncastle is unlikely to have been at the forefront of shop design but some good examples of this type can still be seen in the town, such as 22 North Street (shown to the right).
