ALFORD CONSERVATION AREA APPRAISAL

July 2008

PART A: ALFORD CONSERVATION AREA APPRAISAL

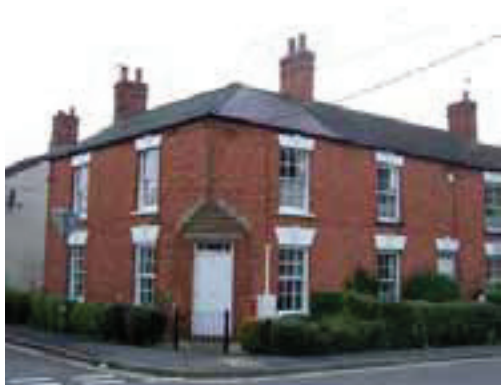
Corbelled corner, 11a Hamilton Road

doors and there are some shopfronts with corner entrances. No 11a Hamilton Road has a particularly attractive corbelled corner. Some C19 bay shopfronts survive but otherwise they are generally plain with undecorated pilasters and cornices. A striking feature travelling from West Street into High Street is the number of canted bay windows at first floor level which appear to float above the pavement. Nos. 119 and 120 West Street are a symmetrical pair of C19 2 storey houses in Farlesthorpe brick with a slate roof and rusticated quoins in brickwork. They have a slightly protruding wide pedimented central gable with two bow windows with leaded canopies and rusticated brickwork quoins with kneeler stones. Each property has a doorway within a porticoed surround with a tripartite fan light.

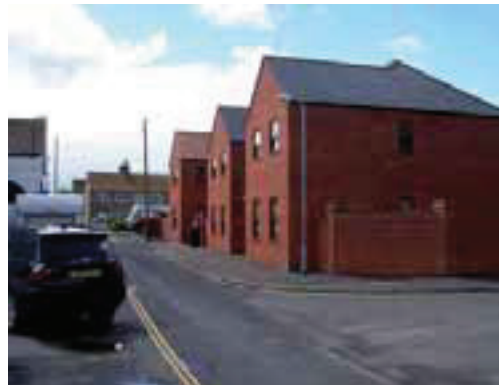
The Old Bowling Green development, Windmill Lane

8.2.2 It is proposed to remove 'The Old Bowling Green' property development off Windmill Lane. This modern red brick development is not in keeping with, and does not compliment, other properties and developments within its immediate setting and the conservation area.

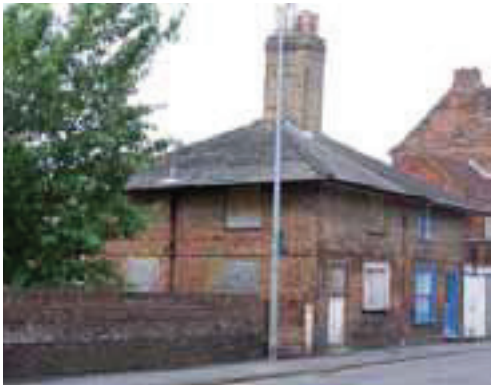
Derelict Listed Buildings, Nos. 12 & 14 South Street

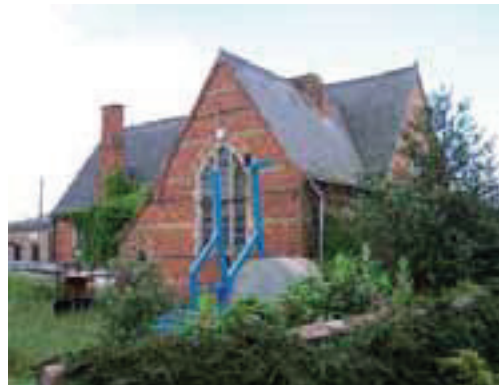
Derelict former Boys School, West Street

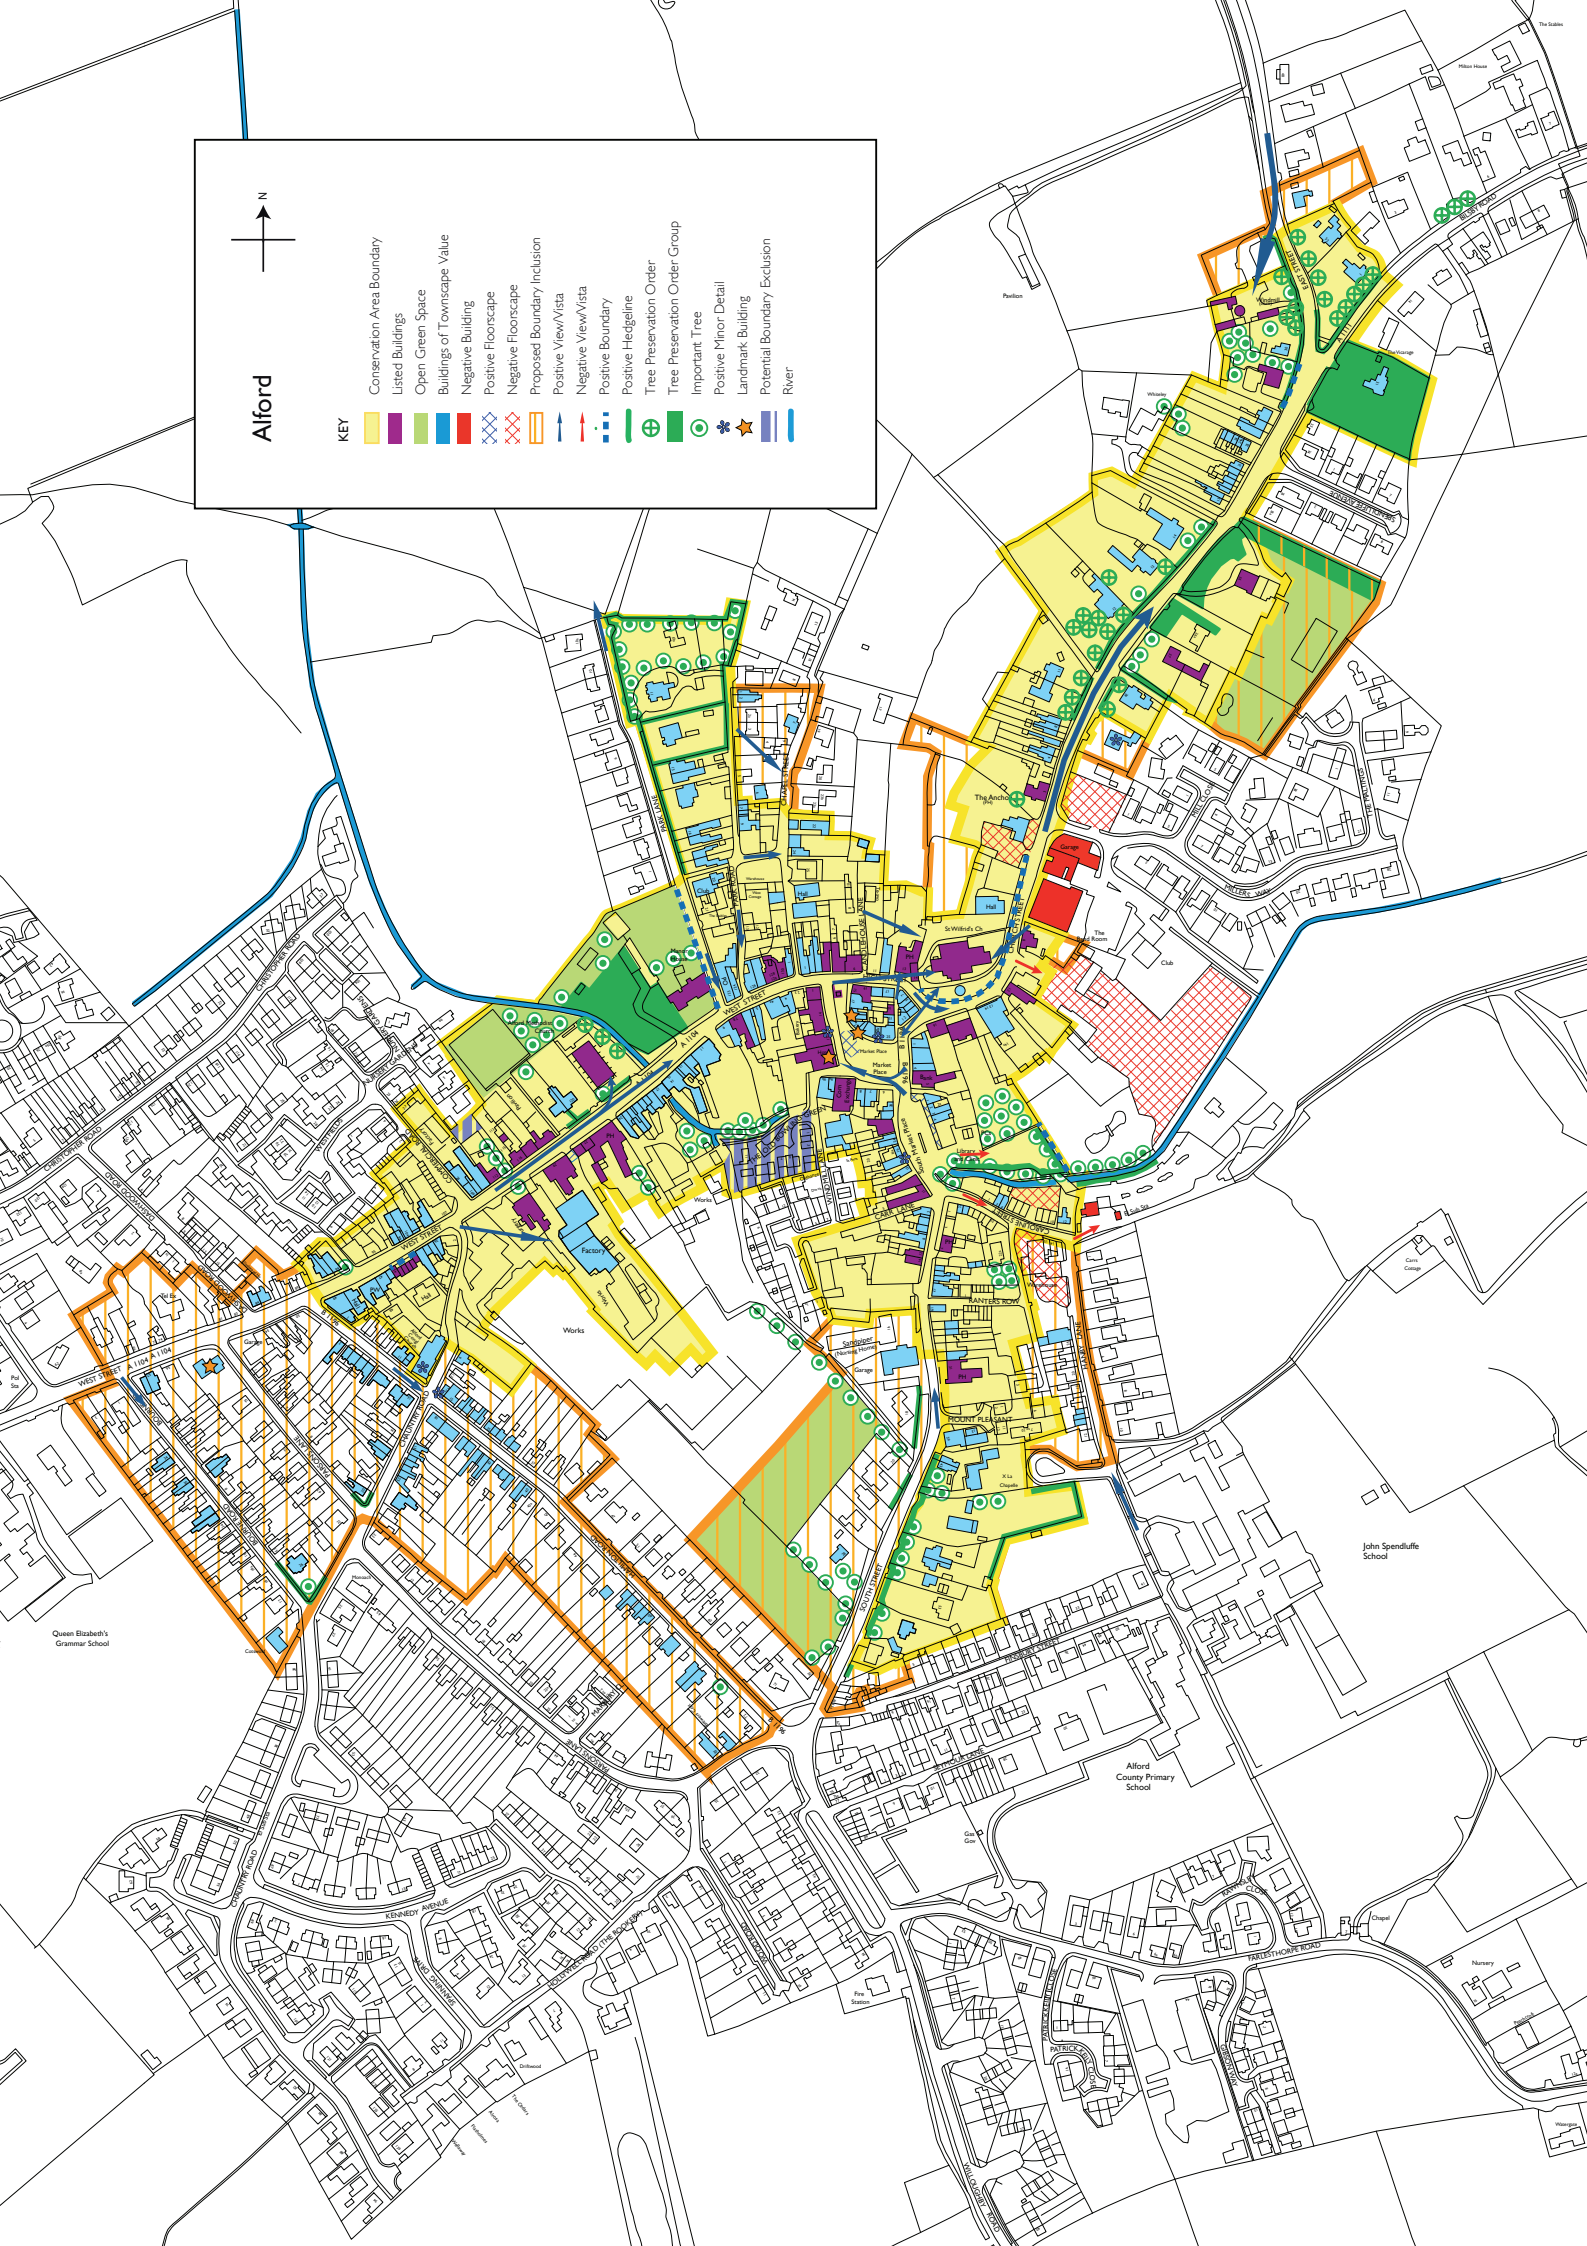
Fig.1 Townscape Analysis Map

- Conservation Area Boundary
- Listed Buildings
- Open Green Space
- Buildings of Townscape Value
- Negative Building
- Positive Floorscape
- Negative Floorscape
- Proposed Boundary Inclusion
- Positive View/Vista
- Negative View/Vista
- Positive Boundary
- Negative Hedge/line
- Tree Preservation Order
- Tree Preservation Order Group
- Important Tree
- Positive Minor Detail
- Landmark Building
- Potential Boundary Exclusion
- River
