# SPILSBY CONSERVATION AREA APPRAISAL

November 2007

DRAFT

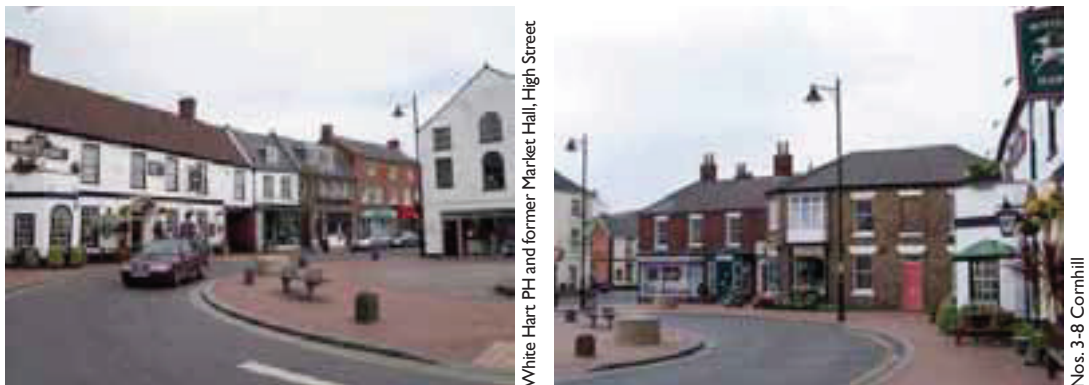
653 The attractive street frontage and the building line are rather spoilt by No.13 (NFU) which is a single storey modern building in a garish red brick. Its scale, which is out of proportion with the rest of the street, does not define the street line and its brick is in contrast with the softer hue of the weathered older brick along the rest of the street. To its right two brick pillars announce an opening which reveals an unattractive view. Looking west along the High Street from this point there is a good view with the expansive white-rendered façade of the White Hart on the right. As the road curves south the buildings step back along Cornhill, with the White Hart's bay front hiding part of No.8

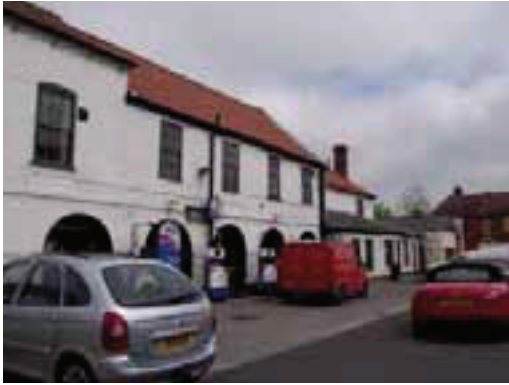
Former Market Hall in use as a garage

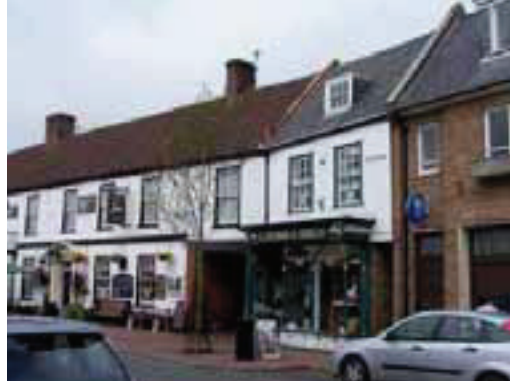
7.53 A number of C19 shopfronts survive on the buildings surrounding the market place and these are often well decorated with details such as cast iron arches, decorative spandrel panels, latticed stallrisers and fascias and cornices supported on elaborate console brackets. A number of well detailed doorcases are evident on the few larger properties of the town. No.31 Halton Road for example has a central 6 panel door with traceried overlight, panelled

Decorative shop front at No. 1 High Street

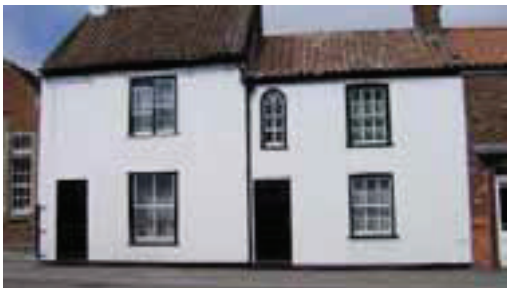
7.62 There are a few examples of stucco also to be found, including the White Hart on the High Street, No.27 High Street and Nos. 8-10 Church Street. The Church of St James is unusually built of greenstone or Spilsby sandstone, with ashlar dressings, and has a lead roof. Spilsby sandstone is a poor building material which explains why it is not widely used. The façade of the theatre (formerly Courthouse) is of sandstone ashlar.

Stucco used at Nos. 8-10 Church Street

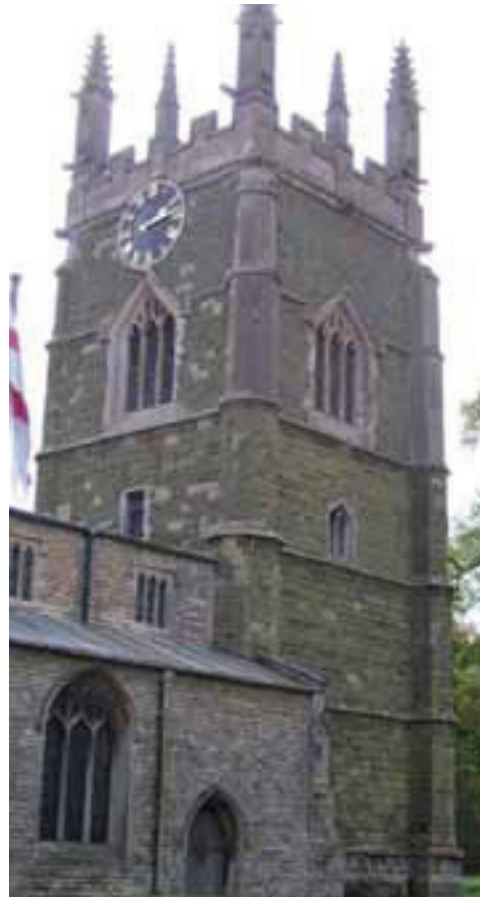
Green stone or Spilsby sandstone in use on St. James's Church Tower

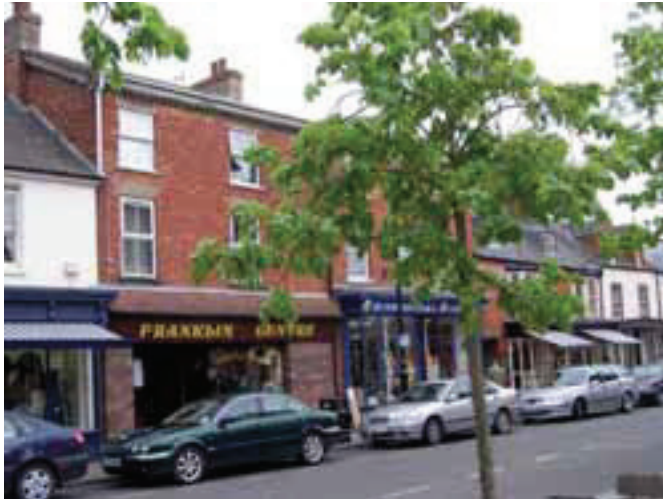
Franklin Centre, High Street

922 No. 14 Market Street has an inappropriate modern single storey box-like extension stuck onto a Victorian building. The signage and shop front at Nos. 20-22 Market Street are somewhat garish and do not respect the rest of the building. The Franklin Centre on the

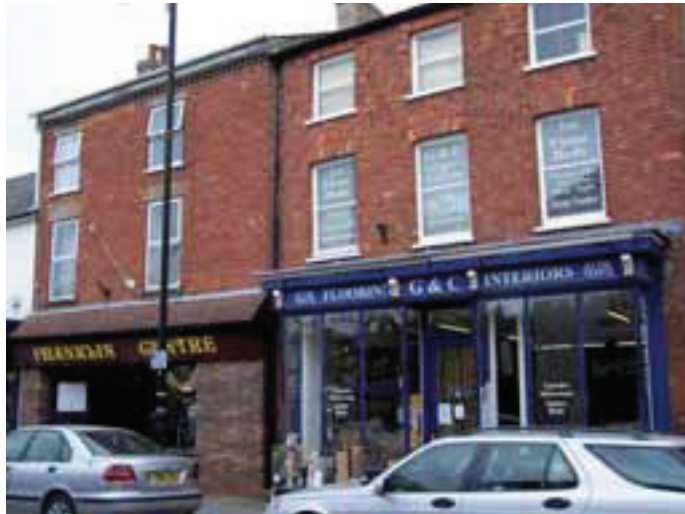
Traditional shop front (right) and inappropriate modern shopfront (left)

11.1.1 Where traditional shopfronts and signage, or elements of them, survive, they should be retained and used as the basis for the restoration of the original frontage or incorporated into an appropriate new shopfront design. Removal of original features will only be permitted if they are beyond repair or are incapable of being successfully incorporated into a new shopfront.

11.1.2 The replacement of inappropriate shopfronts (and signage) will be encouraged provided that the replacement respects the character of the building, adjacent buildings if part of a group or terrace, or the area as a whole. Signage should also respect the character of the building and area as a whole. Signs should always be designed for individual buildings; 'off the peg' designs are not appropriate.

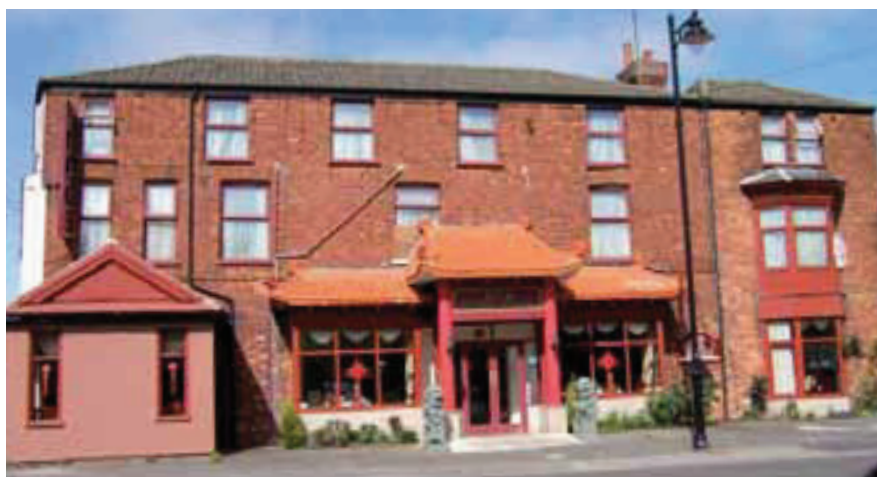
The loss of trees from, particularly the western end of, the conservation area is damaging to its character and appearance. The felling of the trees in front of the former Shades Hotel (now the Beijing Dragon) in particular has eroded the continuity of the tree-line along Church Street and the connection with Eresby Avenue. Replacement tree planting would help to integrated Church Street and Eresby Avenue, whilst screening the front of the former Shades Hotel which is the focus of views north up Eresby Avenue.

Beijing Dragon (former Shades Hotel) - subject of successful enforcement notice
